# Access Compliance Report

## Public Rights-of-Way

### (Curb Ramps)

Intersection ID: 28245	Main Street: SOCIETY_ST	Cross Street: COMMUNITY_HOUSE_RD	Location: E
ADA ID: 881A76EB2CB6	Ramp Type: Perp	Initial Pass/Fail: Fail	Overall Compliance: No
Severity Score: 12.5			
Codes/Mitigation Info/Possible Solution		Field Measurements/Component Compliance

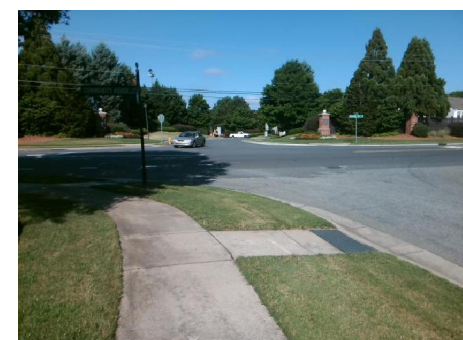
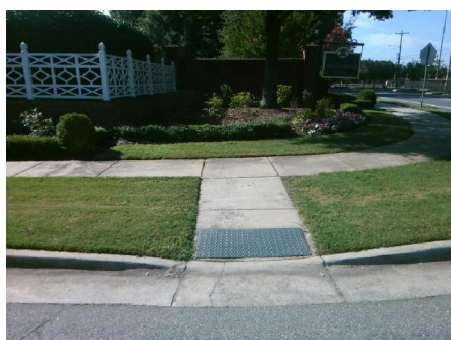
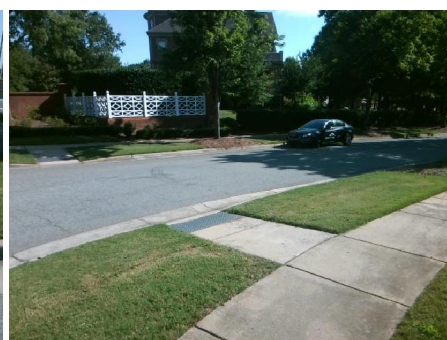
PROW/ADA:

**R304.2.2**

Compliance	Description	Data	Compliance	Description	Data
N/A	Ramp Length (in)	<b>100.0</b>	No	Ramp Slope (%)	<b>11.4</b>
Yes	Ramp Width (in)	<b>54.0</b>	Yes	Ramp XSlope (%)	<b>1.9</b>
N/A	Flare Type LT	<b>N/A</b>	N/A	Flare Type RT	<b>N/A</b>
N/A	Flare Slope LT (%)	<b>N/A</b>	N/A	Flare Slope RT (%)	<b>N/A</b>
N/A	Flare Traversable LT?	<b>N/A</b>	N/A	Flare Traversable RT?	<b>N/A</b>
N/A	Landing Length (in)	<b>N/A</b>	N/A	DWS Provided?	<b>N/A</b>
N/A	Landing Width (in)	<b>N/A</b>	N/A	DWS Contrast?	<b>N/A</b>
N/A	Landing Slope (%)	<b>N/A</b>	N/A	DWS Length (in)	<b>N/A</b>
N/A	Landing X Slope (%)	<b>N/A</b>	N/A	DWS Full Width?	<b>N/A</b>
N/A	Landing Curb? (Y/N)	<b>N/A</b>	N/A	DWS Offset (in)	<b>N/A</b>
N/A	Shared Landing?	<b>N/A</b>			
N/A	Gutter Ponding?	<b>N/A</b>	N/A	Gutter Slope (%)	<b>N/A</b>
N/A	Gutter Lip Ht (in)	<b>N/A</b>	N/A	Gutter X Slope (%)	<b>N/A</b>
N/A	Painted X Walk1?	<b>No</b>	N/A	Painted X Walk2?	<b>N/A</b>

Possible Solutions:

**Remove & Replace Entire Ramp.**

Total Cost: \$ **1850.00**
