Access Compliance Report

Public Rights-of-Way

(Curb Ramps)

Intersection ID: 10033935	Main Street: PARK_RD	Cross Street: N/A	Location: NW
ADA ID: 8822CB9646E1	Ramp Type: PerpDiag	Initial Pass/Fail: Fail	Overall Compliance: No
		Severity Score: 25

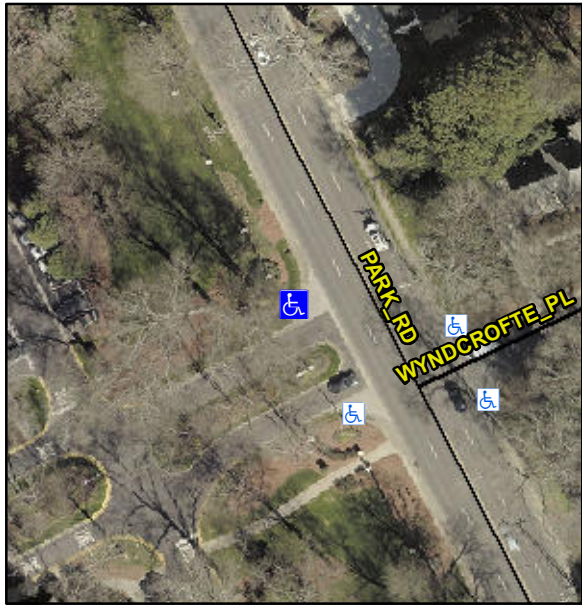
Possible Solutions:		Compliance	Description	Data	Compliance	Description	Data
	Remove & Replace Curb Ramp With Two New Directional Ramps or Equivalent.		N/A	Ramp Length (in)	54.0	No	Ramp Slope (%)	10.7
			Yes	Ramp Width (in)	48.0	No	Ramp XSlope (%)	5.8
			N/A	Flare Type LT	N/A	N/A	Flare Type RT	N/A
			N/A	Flare Slope LT (%)	N/A	N/A	Flare Slope RT (%)	N/A
			N/A	Flare Traversable LT?	N/A	N/A	Flare Traversable RT?	N/A
			N/A	Landing Length (in)	N/A	N/A	DWS Provided?	N/A
			N/A	Landing Width (in)	N/A	N/A	DWS Contrast?	N/A
			N/A	Landing Slope (%)	N/A	N/A	DWS Length (in)	N/A
			N/A	Landing X Slope (%)	N/A	N/A	DWS Full Width?	N/A
Surveyor Notes:		N/A	N/A	Landing Curb? (Y/N)	N/A	N/A	DWS Offset (in)	N/A
PROW/ADA:			N/A	Shared Landing?	N/A			
R304.2.2, R304.5.3			N/A	Gutter Ponding?	N/A	N/A	Gutter Slope (%)	N/A
			N/A	Gutter Lip Ht (in)	N/A	N/A	Gutter X Slope (%)	N/A

N/A	Painted X Walk1?	No	N/A	Painted X Walk2?	No
				X Walk 1 Direction	To SE		X Walk 2 Direction	To E
			N/A	X Walk 1 Width (in)	N/A	N/A	X Walk 2 Width (in)	N/A
				X Walk 1 Slope (%)	1.0		X Walk 2 Slope (%)	2.8
				X Walk 1 X Slope (%)	5.2		X Walk 2 X Slope (%)	1.5
Street 1 Name		ENTRANCE	N/A	Ramp inside XWalk1?	N/A	N/A	Ramp inside XWalk2?	N/A
Stop Condition-Street 2		StopSign		Road Slope (%)	4.1	N/A	Clear Space?	N/A
Street 2 Name		PARK RD		Road X Slope (%)	1.1	N/A	Clear Space to XWalk (in)	N/A
Stop Condition-Street 1		None	N/A	Any Obstructions?	N/A	N/A	Storm Grate/Utility Hazard?	N/A
				Obstruction Type			Storm Grate/Utility Type	
						N/A		N/A
						Yes	Surface Condition? (G/P)	Good
Total Cost:		\$ 3200.00
