Access Compliance Report

Public Rights-of-Way

(Curb Ramps)

Intersection ID: 12170	Main Street: S_POPLAR_ST	Cross Street: W_4TH_ST	Location:	W
ADA ID: 882B4DF786D1	Ramp Type: PerpDiag	Initial Pass/Fail: Fail	Overall Compliance: No	Severity Score: 10
Codes/Mitigation Info/Possible Solution		Field Measurements/Component Compliance

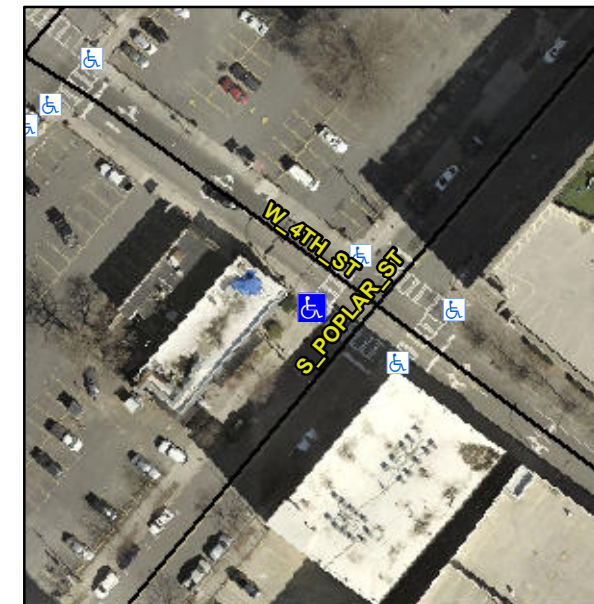
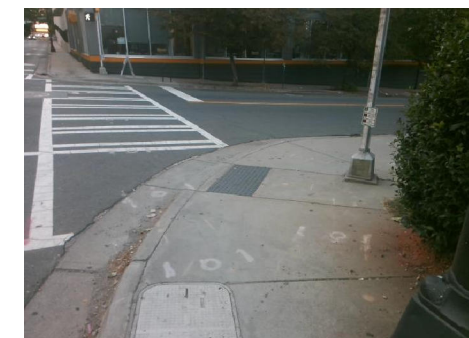
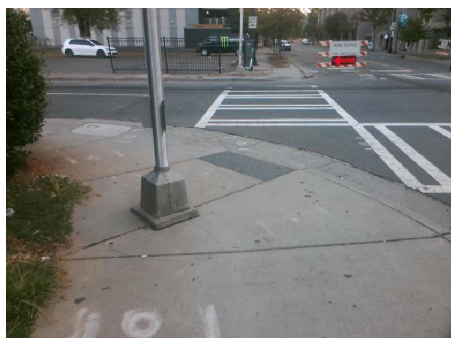
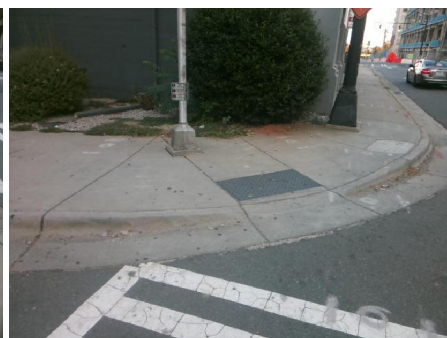
Compliance	Description	Data	Compliance	Description	Data
N/A	Ramp Length (in)	114.0	Yes	Ramp Slope (%)	5.6
No	Ramp Width (in)	47.5	No	Ramp XSlope (%)	4.1
N/A	Flare Type LT	N/A	N/A	Flare Type RT	N/A
N/A	Flare Slope LT (%)	N/A	N/A	Flare Slope RT (%)	N/A
N/A	Flare Traversable LT?	N/A	N/A	Flare Traversable RT?	N/A
N/A	Landing Length (in)	N/A	N/A	DWS Provided?	N/A
N/A	Landing Width (in)	N/A	N/A	DWS Contrast?	N/A
N/A	Landing Slope (%)	N/A	N/A	DWS Length (in)	N/A
N/A	Landing X Slope (%)	N/A	N/A	DWS Full Width?	N/A
N/A	Landing Curb? (Y/N)	N/A	N/A	DWS Offset (in)	N/A
N/A	Shared Landing?	N/A			
N/A	Gutter Ponding?	N/A	N/A	Gutter Slope (%)	N/A
N/A	Gutter Lip Ht (in)	N/A	N/A	Gutter X Slope (%)	N/A
N/A	Painted X Walk1?	Yes	N/A	Painted X Walk2?	Yes
	X Walk 1 Direction	To SE		X Walk 2 Direction	To NE
N/A	X Walk 1 Width (in)	113.0	N/A	X Walk 2 Width (in)	113.0
	X Walk 1 Slope (%)	1.5		X Walk 2 Slope (%)	3.0
	X Walk 1 X Slope (%)	5.2		X Walk 2 X Slope (%)	0.8

N/A	Ramp inside XWalk1?	Yes	N/A	Ramp inside XWalk2?	Yes
	Road Slope (%)	3.8	N/A	Clear Space?	N/A
	Road X Slope (%)	3.0	N/A	Clear Space to XWalk (in)	N/A
N/A	Any Obstructions?	N/A	N/A	Storm Grate/Utility Hazard?	N/A
	Obstruction Type			Storm Grate/Utility Type	
		N/A			N/A
		Yes		Surface Condition? (G/P)	Good

Possible Solutions:

Remove & Replace Curb Ramp With Two New Directional Ramps or Equivalent.

R304.5.1, R304.5.3
