Intersection ID: 54301	Main Street: GOLF_LINKS_DR	Cross Street: PROVIDENCE_FARM_LN	Location:	SE
ADA ID: 883890D63758	Ramp Type: Directional1	Initial Pass/Fail: Fail	Overall Compliance: No	Severity Score: 12.5

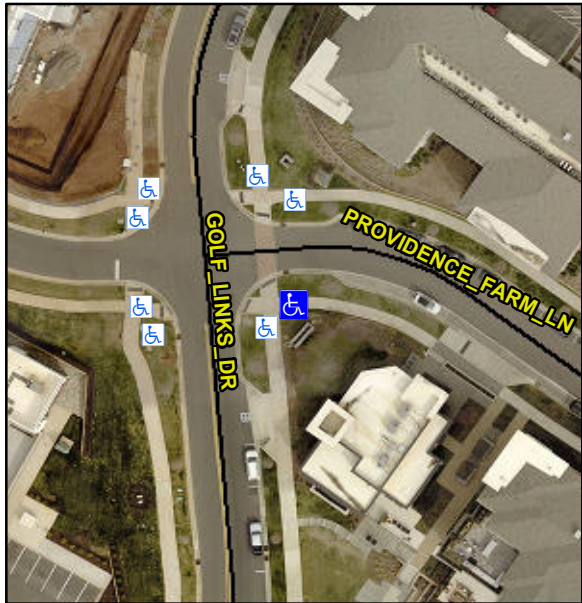
Possible Solutions:		Compliance	Description	Data	Compliance	Description	Data
	Remove & Replace Entire Ramp.		N/A	Ramp Length (in)	81.0	N/A	Grade Break?	N/A
			Yes	Ramp Width (in)	94.0	N/A	Grade Break Slope (%)	0.0
			No	Ramp Slope (%)	8.7	N/A	Grade Break XSlope (%)	0.0
			Yes	Ramp XSlope (%)	0.3			
			N/A	Flare Type LT	N/A	N/A	Flare Type RT	N/A
			N/A	Flare Slope LT (%)	N/A	N/A	Flare Slope RT (%)	0.0
Surveyor Notes:			N/A	Flare Traversable LT?	N/A	N/A	Flare Traversable RT?	N/A
	N/A		N/A	Landing Length (in)	0.0	N/A	DWS Provided?	N/A
			N/A	Landing Width (in)	0.0	N/A	DWS Contrast?	N/A
			N/A	Landing Slope (%)	0.0	N/A	DWS Length (in)	N/A
			N/A	Landing X Slope (%)	0.0	N/A	DWS Full Width?	N/A
PROW/ADA:			N/A	Landing Curb? (Y/N)	N/A	N/A	DWS Offset LT (in)	N/A
	R304.2.2		N/A	Shared Landing?	N/A	N/A	DWS Offset RT (in)	N/A

N/A	Gutter Ponding?	0.0	N/A	Gutter Slope (%)	N/A
			N/A	Gutter Lip Ht (in)	0.0	N/A	Gutter X Slope (%)	N/A
			N/A	Painted X Walk1?	Yes		Road Slope (%)	1.1
				X Walk 1 Direction	To N		Road X Slope (%)	1.2
				X Walk 1 Width (in)	119.5		Clear Space?	N/A
				X Walk 1 Slope (%)	1.1	N/A	Clear Space to XWalk (in)	N/A
				X Walk 1 X Slope (%)	1.2	N/A	Storm Grate/Utility Hazard?	N/A
			N/A	Ramp inside XWalk1?	Yes		Storm Grate/Utility Type	
			N/A	Any Obstructions?	N/A			N/A
				Obstruction Type		Yes	Surface Condition? (G/P)	Good
Total Cost:	\$ 1600.00					N/A	Curb Slope (%)	20.7
