Access Compliance Report Public Rights-of-Way (Curb Ramps)

Main Street: PEPPERPIKE_WY			Cross	Cross Street: MORGAN_LEE_AV				Location:	W
Ramp Type: Perp			Initial	Initial Pass/Fail: Fail Overall Compliance:				o Severity Score:	10
Codes/Mitigation Info/Possible Solution				Field Measurements/Component Compliance					
P	Possible Solutions:			Compliance Description Data			Compliance Description		Data
10	Remove & Replace Entire	Ram	D .	N/A	Ramp Length (in)	49.5	Yes	Ramp Slope (%)	5.8
and the second				No	Ramp Width (in)	47.0	Yes	Ramp XSlope (%)	2.1
				N/A	Flare Type LT	N/A	N/A	Flare Type RT	N/A
				N/A	Flare Slope LT (%	6) N/A	N/A	Flare Slope RT (%)	N/A
1 9				N/A	Flare Traversable	LT? N/A	N/A	Flare Traversable RT?	N/A
1 hr				N/A	Landing Length (ir	n) N/A	N/A	DWS Provided?	N/A
S	Surveyor Notes:			N/A	Landing Width (in)) N/A	N/A	DWS Contrast?	N/A
	N/A			N/A	Landing Slope (%) N/A	N/A	DWS Length (in)	N/A
				N/A	Landing X Slope ((%) N/A	N/A	DWS Full Width?	N/A

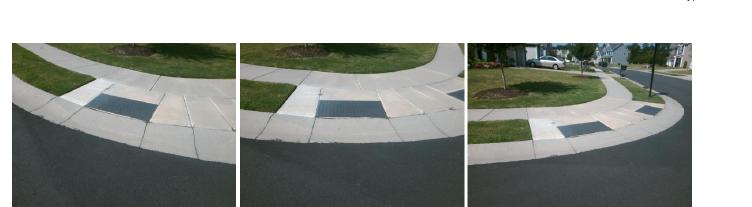
**				N/A	Landing Curb? (Y	/N) N/A	N/A	DWS Offset (in)	N/A
- 3021				N/A	Shared Landing?	N/A			
P	PROW/ADA:			N/A	Gutter Ponding?	N/A	N/A	Gutter Slope (%)	N/A
190	Not Found, R304.5.1			N/A	Gutter Lip Ht (in)	N/A	N/A	Gutter X Slope (%)	N/A
12				N/A	Painted X Walk1?	, No	N/A	Painted X Walk2?	N/A
E					X Walk 1 Directior	n To E		X Walk 2 Direction	N/A
				N/A	X Walk 1 Width (ir	n) N/A	N/A	X Walk 2 Width (in)	N/A
PIKE WY					X Walk 1 Slope (%	%) 3.7		X Walk 2 Slope (%)	N/A
None					X Walk 1 X Slope	(%) 3.1		X Walk 2 X Slope (%)	N/A
N/A				N/A	Ramp inside XWa	alk1? N/A	N/A	Ramp inside XWalk2?	N/A
N/A					Road Slope (%)	N/A	N/A	Clear Space?	N/A
					Road X Slope (%)) N/A	N/A	Clear Space to XWalk (in)	N/A
				N/A	Any Obstructions	? N/A	N/A	Storm Grate/Utility Hazard?	N/A
То	otal Cost:	\$	1850.00		Obstruction Type			Storm Grate/Utility Type	
						N/A			N/A
t	Ramp Type ion Info/P	Ramp Type: Perp sion Info/Possible Solution Possible Solutions: Remove & Replace Entire Surveyor Notes: N/A PROW/ADA: Not Found, R304.5.1	Ramp Type: Perp sion Info/Possible Solution Possible Solutions: Remove & Replace Entire Ram Surveyor Notes: N/A PROW/ADA: Not Found, R304.5.1	Ramp Type: Perp Initial ion Info/Possible Solutions: Possible Solutions: Remove & Replace Entire Ramp. Surveyor Notes: N/A PROW/ADA: None N/A	Ramp Type: Perp Initial Pass/Fa tion Info/Possible Solutions: Comp Remove & Replace Entire Ramp. N/A N/A N/A	Ramp Type: Perp Initial Pass/Fail: Fail tion Info/Possible Solution Field M Possible Solutions: Compliance Description Remove & Replace Entire Ramp. N/A N/A Ramp Width (in) N/A Flare Slope LT (% N/A Landing Length (in) N/A Landing Slope (% N/A N/A N/A Landing Slope (%) N/A Kuster Ponding? N/A Gutter Lip Ht (in) N/A N/A N/A N/A N/A Kuster Lip Ht (in) N/	Ramp Type: Perp Initial Pass/Fail: Fail Overall Compliant tion Info/Possible Solutions: Field Measurements/C Edd Measurements/C Possible Solutions:: Remove & Replace Entire Ramp. N/A Ramp Length (in) 49.5 No Ramp Uength (in) 49.5 No Ramp Length (in) 49.5 No Ramp Length (in) 49.5 No Ramp Length (in) 49.5 No Ramp Uength (in) 49.5 No Ramp Length (in) 49.5 No Ramp Uength (in) 49.5 No Ramp Uength (in) 49.5 N/A Flare Stope LT (%) N/A N/A Flare Stope LT (%) N/A N/A Flare Stope LT (%) N/A N/A Landing Length (in) N/A N/A Landing Stope (%) N/A N/A Landing Curb? (Y/N) N/A N/A N/A Landing Curb? (Y/N) N/A N/A N/A Kalth 1 Direction To E N/A N/A Gutter Ponding? N/A N/A XWalk 1 Stope (%) 3.7 N/A N/A N/A	Ramp Type: Perp Initial Pass/Fail: Fail Overall Compliance: N ion Info/Possible Solution Field Measurements/Compo Data Compliance Description Data Compliance Data Data	Ramp Type: Perp Initial Pass/Fail: Sveral Compliance: No Severity Score: ton Info/Possible Solution: Field Measurements/Component Compliance Compliance Description Data Compliance Description Possible Solutions: Remove & Replace Entire Ramp. N/A Ramp Length (in) 49.5 Yes Ramp Slope (%) N/A Flare Type LT N/A Flare Stope LT (%) N/A Flare Stope RT (%) N/A Flare Traversable LT? N/A Flare Traversable RT? N/A Flare Stope RT (%) N/A Flare Traversable LT? N/A N/A Flare Stope RT (%) N/A Flare Traversable RT? N/A Flare Traversable LT? N/A Landing Urdth (in) N/A N/A DWS Forvided? N/A Landing Stope (%) N/A N/A DWS Full Width? N/A DWS Length (in) N/A Landing Stope (%) N/A Landing Stope (%) N/A N/A DWS Full Width? N/A Landing Stope (%) N/A N/A DWS Full Width? N/A N/A Gutter Ponding? N/A M/A DWS Full Width? N/A Gutter Conding? N/A N/A Gutter Stope (%) N/A

Yes Surface Condition? (G/P)

Good
