# Access Compliance Report

## Public Rights-of-Way

### (Curb Ramps)

| Intersection ID: 11450 | Main Street: GRANDIN_RD | Cross Street: W MARTIN LUTHER KING JR BV | Location: E |

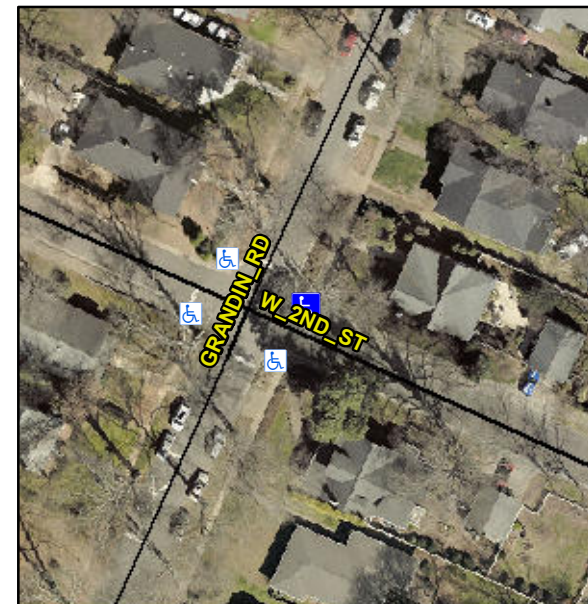
| ADA ID: 884620BF5202 | Ramp Type: Perp | Initial Pass/Fail: Fail | Overall Compliance: No |

**Not Found, R304.5.1**

| Compliance | Description | Data | Compliance | Description | Data |
|---|---|---|---|---|---|
| No | Ramp Width (in) | 47.5 | Yes | Ramp XSlope (%) | 0.7 |

**Remove & Replace Entire Ramp.**
