Access Compliance Report

Public Rights-of-Way

(Curb Ramps)

Intersection ID: 12254	Main Street: BELVEDERE_AV	Cross Street: TIPPAH_AV	Location:	S
ADA ID: 8847829C9CB3	Ramp Type: PerpDiag	Initial Pass/Fail: Fail	Overall Compliance: No	Severity Score: 25
Codes/Mitigation Info/Possible Solution		Field Measurements/Component Compliance

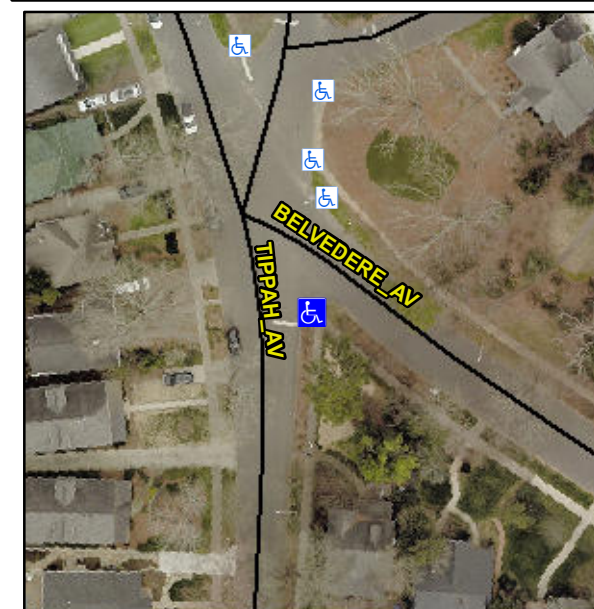
Compliance	Description	Data	Compliance	Description	Data
N/A	Ramp Length (in)	74.0	No	Ramp Slope (%)	9.4
Yes	Ramp Width (in)	64.0	No	Ramp XSlope (%)	5.3
N/A	Flare Type LT	N/A	N/A	Flare Type RT	N/A
N/A	Flare Slope LT (%)	N/A	N/A	Flare Slope RT (%)	N/A
N/A	Flare Traversable LT?	N/A	N/A	Flare Traversable RT?	N/A
N/A	Landing Length (in)	N/A	N/A	DWS Provided?	N/A
N/A	Landing Width (in)	N/A	N/A	DWS Contrast?	N/A
N/A	Landing Slope (%)	N/A	N/A	DWS Length (in)	N/A
N/A	Landing X Slope (%)	N/A	N/A	DWS Full Width?	N/A
N/A	Landing Curb? (Y/N)	N/A	N/A	DWS Offset (in)	N/A
N/A	Shared Landing?	N/A			
N/A	Gutter Ponding?	Yes	N/A	Gutter Slope (%)	N/A
N/A	Gutter Lip Ht (in)	N/A	N/A	Gutter X Slope (%)	N/A
N/A	Painted X Walk1?	No	N/A	Painted X Walk2?	No
	X Walk 1 Direction	To NE		X Walk 2 Direction	To NW
N/A	X Walk 1 Width (in)	N/A	N/A	X Walk 2 Width (in)	N/A
	X Walk 1 Slope (%)	7.9		X Walk 2 Slope (%)	3.2
	X Walk 1 X Slope (%)	1.7		X Walk 2 X Slope (%)	5.1

N/A	Ramp inside XWalk1?	N/A	N/A	Ramp inside XWalk2?	N/A
	Road Slope (%)	0.9	N/A	Clear Space?	N/A
	Road X Slope (%)	8.0	N/A	Clear Space to XWalk (in)	N/A
N/A	Any Obstructions?	N/A	N/A	Storm Grate/Utility Hazard?	N/A
	Obstruction Type			Storm Grate/Utility Type	
		N/A			N/A
		Yes		Surface Condition? (G/P)	Good

Possible Solutions:

Remove & Replace Curb Ramp With Two New Directional Ramps or Equivalent.

R304.2.2, R304.5.3
