# Access Compliance Report

## Public Rights-of-Way

### (Curb Ramps)

| Intersection ID: 8697 | Main Street: HOLLAND_AV | Cross Street: ISENHOUR_ST | Location: SE |

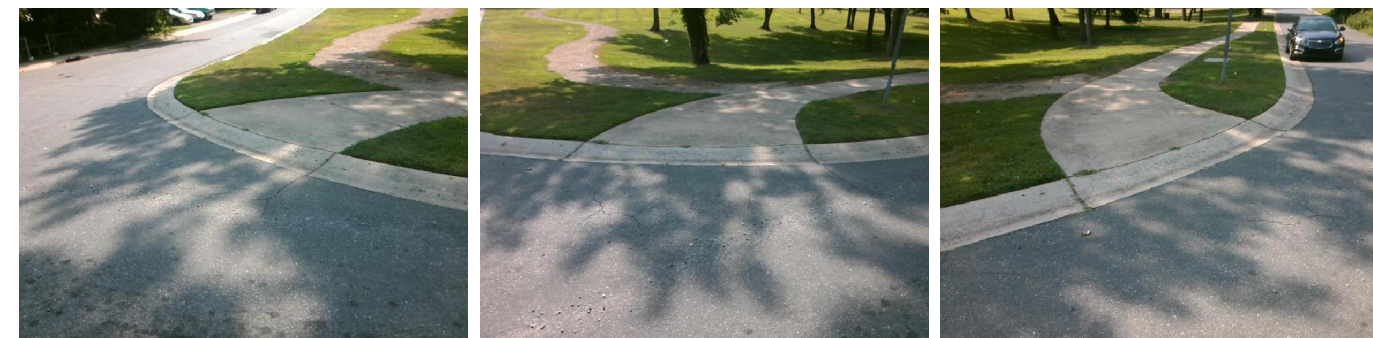
| ADA ID: 885DD6213CA6 | Ramp Type: BlendTrans1 | Initial Pass/Fail: Pass | Overall Compliance: No |
| | | Severity Score: 22.5 | |
