Access Compliance Report

Public Rights-of-Way

(Curb Ramps)

Intersection ID: 18387	Main Street: BURTONWOOD_CR	Cross Street: MONROE_RD	Location: NE
ADA ID: 885EA78DED12	Ramp Type: PerpDiag	Initial Pass/Fail: Fail	Overall Compliance: No
			Severity Score: 26.25

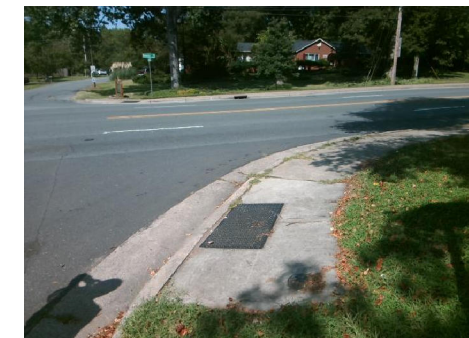
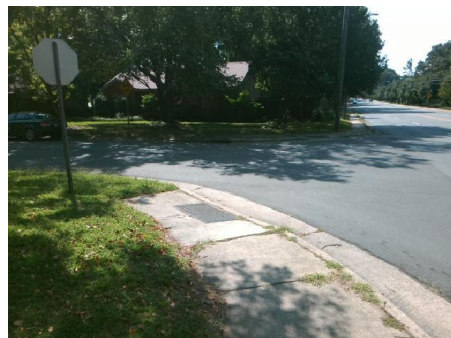
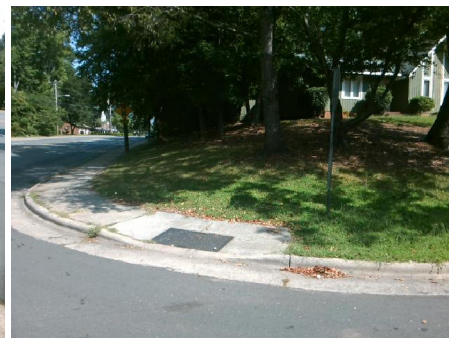
Not Found, R304.2.2, R304.5.3

Compliance	Description	Data	Compliance	Description	Data
N/A	Ramp Length (in)	58.0	No	Ramp Slope (%)	12.4
Yes	Ramp Width (in)	48.0	No	Ramp XSlope (%)	3.5
N/A	Flare Type LT	N/A	N/A	Flare Type RT	N/A
N/A	Flare Slope LT (%)	N/A	N/A	Flare Slope RT (%)	N/A
N/A	Flare Traversable LT?	N/A	N/A	Flare Traversable RT?	N/A
N/A	Landing Length (in)	N/A	N/A	DWS Provided?	N/A
N/A	Landing Width (in)	N/A	N/A	DWS Contrast?	N/A
N/A	Landing Slope (%)	N/A	N/A	DWS Length (in)	N/A
N/A	Landing X Slope (%)	N/A	N/A	DWS Full Width?	N/A
N/A	Landing Curb? (Y/N)	N/A	N/A	DWS Offset (in)	N/A
N/A	Shared Landing?	N/A			
N/A	Gutter Ponding?	N/A	N/A	Gutter Slope (%)	N/A
N/A	Gutter Lip Ht (in)	N/A	N/A	Gutter X Slope (%)	N/A
N/A	Painted X Walk1?	No	N/A	Painted X Walk2?	No
	X Walk 1 Direction	To W		X Walk 2 Direction	To S
N/A	X Walk 1 Width (in)	N/A	N/A	X Walk 2 Width (in)	N/A
	X Walk 1 Slope (%)	1.9		X Walk 2 Slope (%)	0.0
	X Walk 1 X Slope (%)	1.3		X Walk 2 X Slope (%)	1.3

N/A	Ramp inside XWalk1?	N/A	N/A	Ramp inside XWalk2?	N/A
	Road Slope (%)	1.0	N/A	Clear Space?	N/A
	Road X Slope (%)	0.3	N/A	Clear Space to XWalk (in)	N/A
N/A	Any Obstructions?	N/A	N/A	Storm Grate/Utility Hazard?	N/A
	Obstruction Type			Storm Grate/Utility Type	
		N/A			N/A
			Yes	Surface Condition? (G/P)	Good

Remove & Replace Curb Ramp With Two New Directional Ramps or Equivalent.
