# Access Compliance Report

## Public Rights-of-Way

### (Curb Ramps)

Intersection ID: 30579	Main Street: CIRCLEGREEN_DR	Cross Street: TRICKLING_WATER_CT	Location: S
ADA ID: 885EB0C96F2E	Ramp Type: PerpDiag	Initial Pass/Fail: Fail	Overall Compliance: No
		Severity Score: 12.5

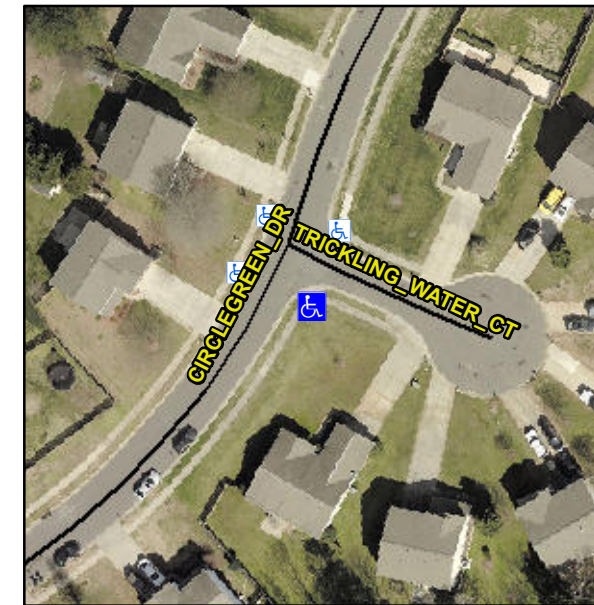
Compliance	Description	Data	Compliance	Description	Data
N/A	Ramp Length (in)	46.5	Yes	Ramp Slope (%)	7.2
Yes	Ramp Width (in)	48.0	No	Ramp XSlope (%)	5.5
N/A	Flare Type LT	N/A	N/A	Flare Type RT	N/A
N/A	Flare Slope LT (%)	N/A	N/A	Flare Slope RT (%)	N/A
N/A	Flare Traversable LT?	N/A	N/A	Flare Traversable RT?	N/A
N/A	Landing Length (in)	N/A	N/A	DWS Provided?	N/A
N/A	Landing Width (in)	N/A	N/A	DWS Contrast?	N/A
N/A	Landing Slope (%)	N/A	N/A	DWS Length (in)	N/A
N/A	Landing X Slope (%)	N/A	N/A	DWS Full Width?	N/A
N/A	Landing Curb? (Y/N)	N/A	N/A	DWS Offset (in)	N/A
N/A	Shared Landing?	N/A			
N/A	Gutter Ponding?	N/A	N/A	Gutter Slope (%)	N/A
N/A	Gutter Lip Ht (in)	N/A	N/A	Gutter X Slope (%)	N/A
N/A	Painted X Walk1?	No	N/A	Painted X Walk2?	No
	X Walk 1 Direction	To NE		X Walk 2 Direction	To NW
N/A	X Walk 1 Width (in)	N/A	N/A	X Walk 2 Width (in)	N/A
	X Walk 1 Slope (%)	2.5		X Walk 2 Slope (%)	4.4
	X Walk 1 X Slope (%)	5.3		X Walk 2 X Slope (%)	0.5

N/A	Ramp inside XWalk1?	N/A	N/A	Ramp inside XWalk2?	N/A
	Road Slope (%)	1.8	N/A	Clear Space?	N/A
	Road X Slope (%)	4.2	N/A	Clear Space to XWalk (in)	N/A
N/A	Any Obstructions?	N/A	N/A	Storm Grate/Utility Hazard?	N/A
	Obstruction Type			Storm Grate/Utility Type	
		N/A			N/A
			Yes	Surface Condition? (G/P)	Good

**Remove & Replace Curb Ramp With Two New Directional Ramps or Equivalent.**

**R304.5.3**
