Access Compliance Report Public Rights-of-Way (Curb Ramps)

Intersection ID: 21102 Main Street: S_TRYON_ST Cross Street: WHITEHALL_PARK_DR Location: N

ADA ID: 88797B1CCD01 Ramp Type: Para Initial Pass/Fail: Fail Overall Compliance: No Severity Score: 12.5

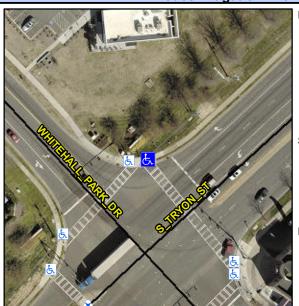
Field Measurements/Component Compliance						
Comp	liance Description	Data	Comp	liance Description	Data	
N/A	Ramp Length LT (in)	72.0	N/A	Ramp Length RT (in)	64.0	
Yes	Ramp Width LT (in)	89.0	Yes	Ramp Width RT (in)	90.0	
No	Ramp Slope LT (%)	8.8	Yes	Ramp Slope RT (%)	6.6	
Yes	Ramp XSlope LT (%)	0.6	Yes	Ramp XSlope RT (%)	2.0	
N/A	Landing Length (in)	N/A	N/A	DWS Provided?	N/A	
N/A	Landing Width (in)	N/A	N/A	DWS Contrast?	N/A	
N/A	Landing Slope (%)	N/A	N/A	DWS Length (in)	N/A	
N/A	Landing X Slope (%)	N/A	N/A	DWS Full Width?	N/A	
N/A	Landing Curb? (Y/N)	N/A	N/A	DWS Offset (in)	N/A	
N/A	Shared Landing?	N/A				
N/A	Gutter Ponding?	N/A	N/A	Gutter Slope (%)	N/A	
N/A	Gutter Lip Ht (in)	N/A	N/A	Gutter X Slope (%)	N/A	
N/A	Painted X Walk1?	Yes	N/A	Painted X Walk2?	N/A	
	X Walk 1 Direction	To SE		X Walk 2 Direction	N/A	
N/A	X Walk 1 Width (in)	115.0	N/A	X Walk 2 Width (in)	N/A	
	X Walk 1 Slope (%)	0.9		X Walk 2 Slope (%)	N/A

X Walk 1 X Slope (%)	1.0		X Walk 2 X Slope (%)	N/A	
N/A	Ramp inside XWalk1?	Yes	N/A	Ramp inside XWalk2?	N/A	
	Road Slope (%)	N/A	N/A	Clear Space?	N/A	
	Road X Slope (%)	N/A	N/A	Clear Space to XWalk (in)	N/A	
N/A	Any Obstructions?	N/A	N/A	Storm Grate/Utility Hazard?	N/A	
	Obstruction Type			Storm Grate/Utility Type		
		N/A			N/A	
			Yes	Surface Condition? (G/P)	Good	
			N/A	Curb Slope (%)	2.5	
	Section 1987

Possible Solutions:	Co
Remove & Replace Entire Ramp.	N/A
	Ye
	No
	Ye
	N/A
	N/A
Surveyor Notes:	N/A
N/A	N/A
	N/A
	N/A
	N/A
PROW/ADA:	N/A
R304.3.2	N/A
	N/A
	N/A
