Access Compliance Report

Public Rights-of-Way

(Curb Ramps)

Intersection ID: 21533	Main Street: LENOX_POINTE_DR	Cross Street: KINGS_PARADE_BV	Location: E
ADA ID: 887D64C53D30	Ramp Type: Perp	Initial Pass/Fail: Fail	Overall Compliance: No
Severity Score: 21.25			
Codes/Mitigation Info/Possible Solution		Field Measurements/Component Compliance

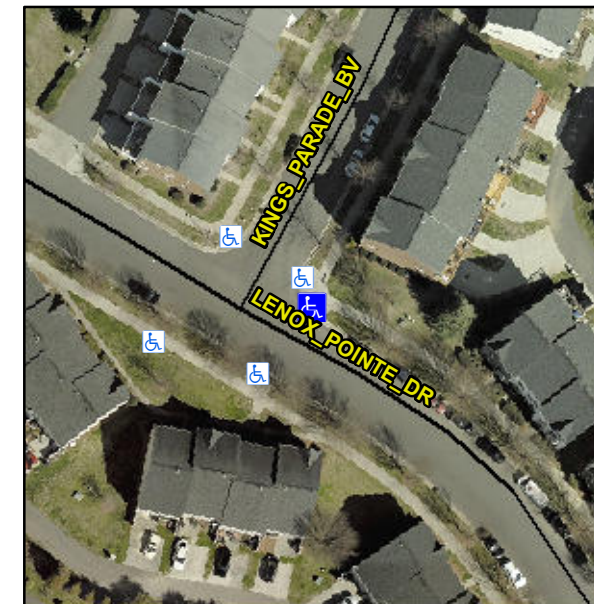
Not Found, R304.5.1, R304.2.2

Compliance	Description	Data	Compliance	Description	Data
N/A	Ramp Length (in)	76.0	No	Ramp Slope (%)	10.2
No	Ramp Width (in)	46.0	Yes	Ramp XSlope (%)	1.1
N/A	Flare Type LT	N/A	N/A	Flare Type RT	N/A
N/A	Flare Slope LT (%)	N/A	N/A	Flare Slope RT (%)	N/A
N/A	Flare Traversable LT?	N/A	N/A	Flare Traversable RT?	N/A
N/A	Landing Length (in)	N/A	N/A	DWS Provided?	N/A
N/A	Landing Width (in)	N/A	N/A	DWS Contrast?	N/A
N/A	Landing Slope (%)	N/A	N/A	DWS Length (in)	N/A
N/A	Landing X Slope (%)	N/A	N/A	DWS Full Width?	N/A
N/A	Landing Curb? (Y/N)	N/A	N/A	DWS Offset (in)	N/A
N/A	Shared Landing?	N/A			
N/A	Gutter Ponding?	N/A	N/A	Gutter Slope (%)	N/A
N/A	Gutter Lip Ht (in)	N/A	N/A	Gutter X Slope (%)	N/A
N/A	Painted X Walk1?	No	N/A	Painted X Walk2?	N/A
	X Walk 1 Direction	To SW		X Walk 2 Direction	N/A
N/A	X Walk 1 Width (in)	N/A	N/A	X Walk 2 Width (in)	N/A
	X Walk 1 Slope (%)	2.6		X Walk 2 Slope (%)	N/A
	X Walk 1 X Slope (%)	1.6		X Walk 2 X Slope (%)	N/A

Remove & Replace Entire Ramp.
