Access Compliance Report

Public Rights-of-Way

(Curb Ramps)

Intersection ID: N/A	Main Street: WILKINSON_BV	Cross Street: N/A	Location: SW
ADA ID: 8882BCEFC89F	Ramp Type: Directional2	Initial Pass/Fail: Fail	Overall Compliance: No
		Severity Score: 2.75

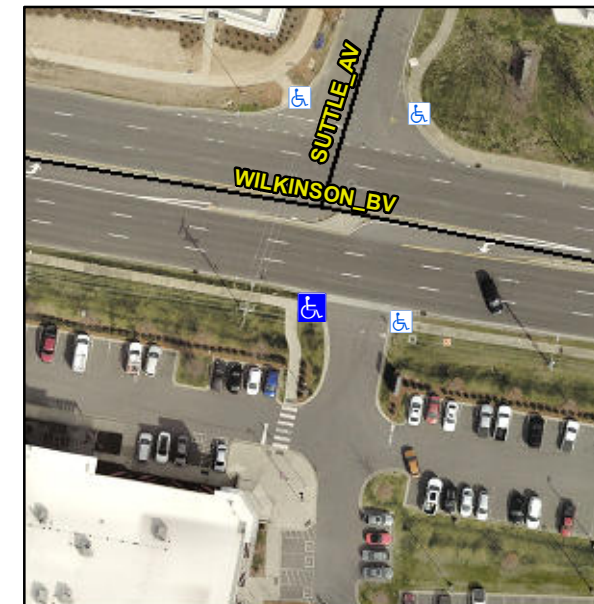
**R304.2.2, R304.5.3, R304.2.1,
R304.2.2-Perp, R304.3.2-Para,
R302.7.2, R304.5.4**

Compliance	Description	Data	Compliance	Description	Data
N/A	Ramp Length (in)	96.0	N/A	Grade Break?	N/A
Yes	Ramp Width (in)	53.0	N/A	Grade Break Slope (%)	0.0
No	Ramp Slope (%)	9.1	N/A	Grade Break XSlope (%)	0.0
No	Ramp XSlope (%)	4.7			
N/A	Flare Type LT	N/A	N/A	Flare Type RT	N/A
N/A	Flare Slope LT (%)	N/A	N/A	Flare Slope RT (%)	0.0
N/A	Flare Traversable LT?	No	N/A	Flare Traversable RT?	No
No	Landing Length (in)	0.0	N/A	DWS Provided?	N/A
No	Landing Width (in)	0.0	N/A	DWS Contrast?	N/A
No	Landing Slope (%)	0.0	N/A	DWS Length (in)	N/A
No	Landing X Slope (%)	0.0	N/A	DWS Full Width?	N/A
N/A	Landing Curb? (Y/N)	N/A	N/A	DWS Offset LT (in)	N/A
N/A	Shared Landing?	N/A	N/A	DWS Offset RT (in)	N/A
Yes	Gutter Ponding?	0.0	No	Gutter Slope (%)	N/A
No	Gutter Lip Ht (in)	0.0	No	Gutter X Slope (%)	N/A
N/A	Painted X Walk1?	No		Road Slope (%)	5.0
	X Walk 1 Direction	To E		Road X Slope (%)	7.1
	X Walk 1 Width (in)	N/A		Clear Space?	N/A

X Walk 1 Slope (%)	5.0	N/A	Clear Space to XWalk (in)	N/A
	X Walk 1 X Slope (%)	7.1	Yes	Storm Grate/Utility Hazard?	N/A
N/A	Ramp inside XWalk1?	N/A		Storm Grate/Utility Type	
Yes	Any Obstructions?	N/A			N/A
	Obstruction Type		Yes	Surface Condition? (G/P)	Good
			N/A	Curb Slope (%)	2.2

**Remove & Replace Entire Ramp.
Remove & Replace Gutter.**

Total Cost: \$ 2550.00
