Access Compliance Report Public Rights-of-Way (Curb Ramps)

Intersection ID: 20659 Main Street: ARCHDALE_DR Cross Street: PARK_RD Location: SW

ADA ID: 88A40A1BB55C Ramp Type: PerpDiag Initial Pass/Fail: Pass Overall Compliance: No Severity Score: 27.75

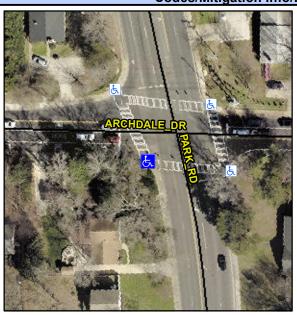
Not Found, R304.2.1, R304.2.2-Perp, R304.3.2-Para, R304.5.3, R304.2.3, R305, R304.5.4

Comp	liance Description	Data	Com	oliance Description	Data
N/A	Ramp Length (in)	53.5	Yes	Ramp Slope (%)	5.2
Yes	Ramp Width (in)	48.0	Yes	Ramp XSlope (%)	3.7
N/A	Flare Type LT	Sloped	N/A	Flare Type RT	N/A
N/A	Flare Slope LT (%)	12.0	Yes	Flare Slope RT (%)	5.4
N/A	Flare Traversable LT?	Yes	N/A	Flare Traversable RT?	Yes
No	Landing Length (in)	N/A	No	DWS Provided?	No
No	Landing Width (in)	N/A	N/A	DWS Contrast?	No
No	Landing Slope (%)	N/A	N/A	DWS Length (in)	N/A
No	Landing X Slope (%)	N/A	N/A	DWS Full Width?	No
N/A	Landing Curb? (Y/N)	No	N/A	DWS Offset (in)	N/A
N/A	Shared Landing?	N/A			
Yes	Gutter Ponding?	No	No	Gutter Slope (%)	6.3
Yes	Gutter Lip Ht (in)	0.0	Yes	Gutter X Slope (%)	4.4
N/A	Painted X Walk1?	Yes	N/A	Painted X Walk2?	Yes
	X Walk 1 Direction	To SE		X Walk 2 Direction	To NW
N/A	X Walk 1 Width (in)	94.0	N/A	X Walk 2 Width (in)	66.5
	X Walk 1 Slope (%)	4.4		X Walk 2 Slope (%)	1.5
	X Walk 1 X Slope (%)	4.2		X Walk 2 X Slope (%)	4.9

Yes	Ramp inside XWalk1?	Yes	Yes	Ramp inside XWalk2?	Yes
	Road Slope (%)	5.0	N/A	Clear Space?	Yes
	Road X Slope (%)	1.2	No	Clear Space to XWalk (in)	42.0
Yes	Any Obstructions?	No	Yes	Storm Grate/Utility Hazard?	No
	Obstruction Type			Storm Grate/Utility Type	
		N/A			N/A
			Yes	Surface Condition? (G/P)	Good

Remove & Replace Curb Ramp With
Two New Directional Ramps or
Equivalent. Restripe Crosswalk(s)
To Provide Clear space. Remove &
Replace Gutter.
