# Access Compliance Report

## Public Rights-of-Way

### (Curb Ramps)

| Intersection ID: 44070 | Main Street: SEDGEMOOR_LN | Cross Street: SOUTHAMPTON_COMMONS_DR | Location: SE |

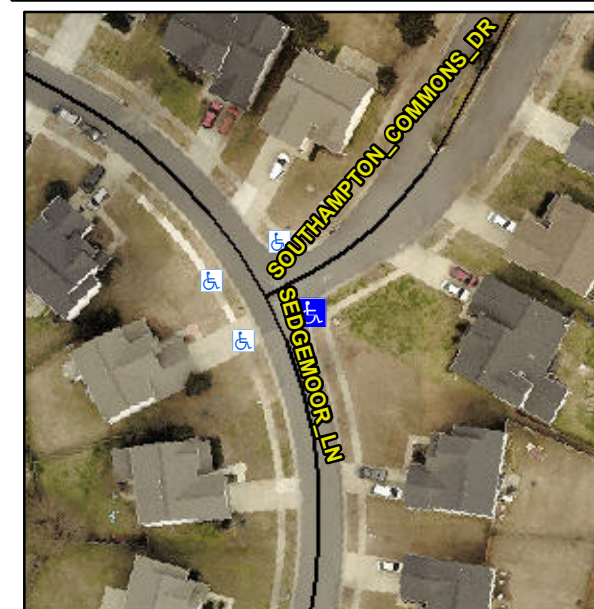
| ADA ID: 88A47345947E | Ramp Type: PerpDiag | Initial Pass/Fail: Fail | Overall Compliance: No |
| Severity Score: 21.25 | | | |

| Compliance | Description | Data | Compliance | Description | Data |
|---|---|---|---|---|---|
| N/A | Ramp Length (in) | 73.0 | Yes | Ramp Slope (%) | 6.5 |
| No | Ramp Width (in) | 37.0 | No | Ramp XSlope (%) | 6.2 |

**Remove & Replace Curb Ramp With Two New Directional Ramps or Equivalent.**

**R304.5.1, R304.5.3**

Total Cost: \$ 3200.00
