Access Compliance Report

Public Rights-of-Way

(Curb Ramps)

Intersection ID: 8857	Main Street: DORTON_ST	Cross Street: N_TRYON_ST	Location: SW
ADA ID: 88A6008E8643	Ramp Type: Perp	Initial Pass/Fail: Fail	Overall Compliance: No
		Severity Score: 10

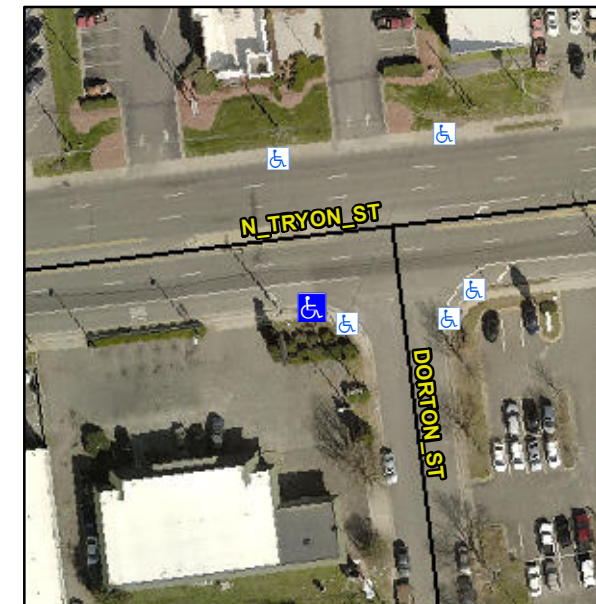
Not Found, R304.5.1

Compliance	Description	Data	Compliance	Description	Data
N/A	Ramp Length (in)	71.0	Yes	Ramp Slope (%)	6.3
No	Ramp Width (in)	47.5	Yes	Ramp XSlope (%)	3.7
N/A	Flare Type LT	N/A	N/A	Flare Type RT	N/A
N/A	Flare Slope LT (%)	N/A	N/A	Flare Slope RT (%)	N/A
N/A	Flare Traversable LT?	N/A	N/A	Flare Traversable RT?	N/A
N/A	Landing Length (in)	N/A	N/A	DWS Provided?	N/A
N/A	Landing Width (in)	N/A	N/A	DWS Contrast?	N/A
N/A	Landing Slope (%)	N/A	N/A	DWS Length (in)	N/A
N/A	Landing X Slope (%)	N/A	N/A	DWS Full Width?	N/A
N/A	Landing Curb? (Y/N)	N/A	N/A	DWS Offset (in)	N/A
N/A	Shared Landing?	N/A			
N/A	Gutter Ponding?	N/A	N/A	Gutter Slope (%)	N/A
N/A	Gutter Lip Ht (in)	N/A	N/A	Gutter X Slope (%)	N/A
N/A	Painted X Walk1?	No	N/A	Painted X Walk2?	N/A
	X Walk 1 Direction	To N		X Walk 2 Direction	N/A
N/A	X Walk 1 Width (in)	N/A	N/A	X Walk 2 Width (in)	N/A
	X Walk 1 Slope (%)	2.9		X Walk 2 Slope (%)	N/A
	X Walk 1 X Slope (%)	4.0		X Walk 2 X Slope (%)	N/A

N/A	Ramp inside XWalk1?	N/A	N/A	Ramp inside XWalk2?	N/A
	Road Slope (%)	N/A	N/A	Clear Space?	N/A
	Road X Slope (%)	N/A	N/A	Clear Space to XWalk (in)	N/A
N/A	Any Obstructions?	N/A	N/A	Storm Grate/Utility Hazard?	N/A
	Obstruction Type			Storm Grate/Utility Type	
		N/A			N/A
			Yes	Surface Condition? (G/P)	Good

Remove & Replace Entire Ramp.

Total Cost: \$ 1850.00
