# Access Compliance Report

## Public Rights-of-Way

### (Curb Ramps)

Intersection ID: 21105	Main Street: CHADWICK_PL	Cross Street: SHARON_VIEW_RD	Location: NW
ADA ID: 88B78E01E0E7	Ramp Type: BlendTrans1	Initial Pass/Fail: Fail	Overall Compliance: No
Severity Score: 8.75			
Codes/Mitigation Info/Possible Solution		Field Measurements/Component Compliance

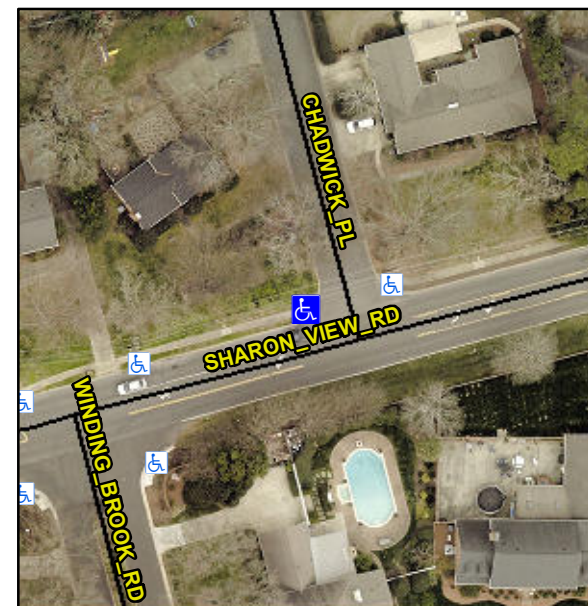
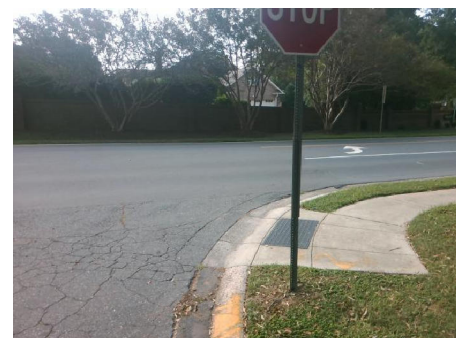
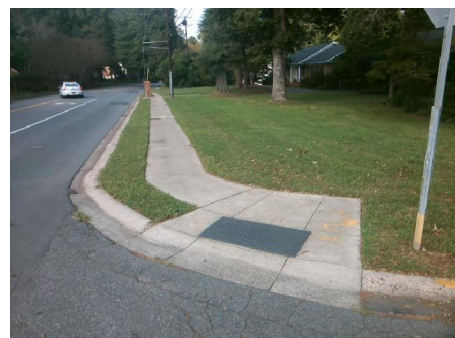
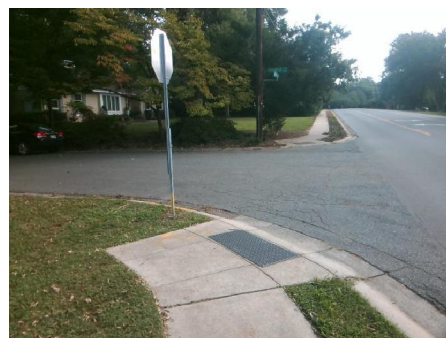
Compliance	Description	Data	Compliance	Description	Data
N/A	Ramp Length (in)	26.5	Yes	BlendTrans Slope (%)	3.1
No	Ramp Width (in)	39.0	Yes	BlendTrans XSlope (%)	0.6
N/A	Flare Type LT	N/A	N/A	Flare Type RT	N/A
N/A	Flare Slope LT (%)	N/A	N/A	Flare Slope RT (%)	N/A
N/A	Flare Traversable LT?	N/A	N/A	Flare Traversable RT?	N/A
N/A	Landing Length (in)	N/A	N/A	DWS Provided?	N/A
N/A	Landing Width (in)	N/A	N/A	DWS Contrast?	N/A
N/A	Landing Slope (%)	N/A	N/A	DWS Length (in)	N/A
N/A	Landing X Slope (%)	N/A	N/A	DWS Full Width?	N/A
N/A	Landing Curb? (Y/N)	N/A	N/A	DWS Offset (in)	N/A
N/A	Shared Landing?	N/A			
N/A	Gutter Ponding?	N/A	N/A	Gutter Slope (%)	N/A
N/A	Gutter Lip Ht (in)	N/A	N/A	Gutter X Slope (%)	N/A
N/A	Painted X Walk1?	No	N/A	Painted X Walk2?	No
	X Walk 1 Direction	To SE		X Walk 2 Direction	To NE
	X Walk 1 Width (in)	N/A		X Walk 2 Width (in)	N/A
	X Walk 1 Slope (%)	3.9		X Walk 2 Slope (%)	3.7
	X Walk 1 X Slope (%)	3.6		X Walk 2 X Slope (%)	5.8

N/A	Ramp inside XWalk1?	N/A	N/A	Ramp inside XWalk2?	N/A
	Road Slope (%)	3.3		Clear Space?	N/A
	Road X Slope (%)	3.7	N/A	Clear Space to XWalk (in)	N/A
N/A	Any Obstructions?	N/A	N/A	Storm Grate/Utility Hazard?	N/A
	Obstruction Type			Storm Grate/Utility Type	
		N/A			N/A
			Yes	Surface Condition? (G/P)	Good
			No	Curb Slope (%)	9.5

**Remove & Replace Curb Ramp With Two New Directional Ramps or Equivalent.**

**Not Found, R304.5.1**
