# Access Compliance Report

## Public Rights-of-Way

Intersection ID: 31651	Main Street: MAZEN_CT	Cross Street: WILLIAM_REYNOLDS_DR	Location: NW
ADA ID: 88B93D24981C	Ramp Type: PerpDiag	Initial Pass/Fail: Fail	Overall Compliance: No
Severity Score: 10			
Codes/Mitigation Info/Possible Solution		Field Measurements/Component Compliance

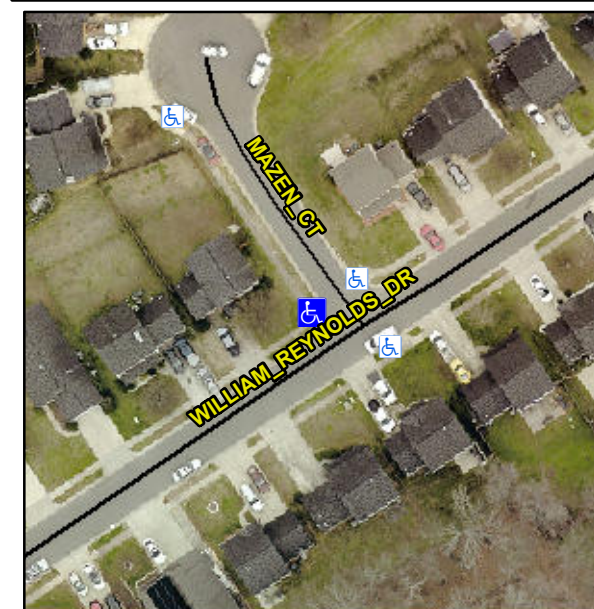
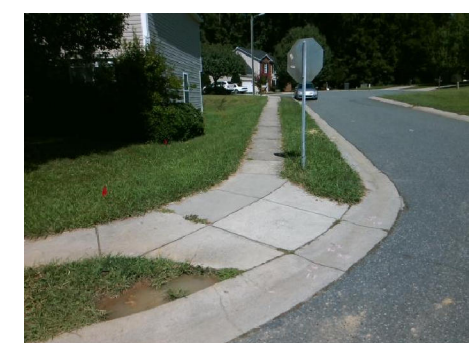
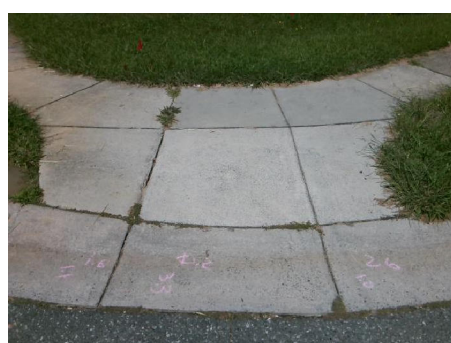
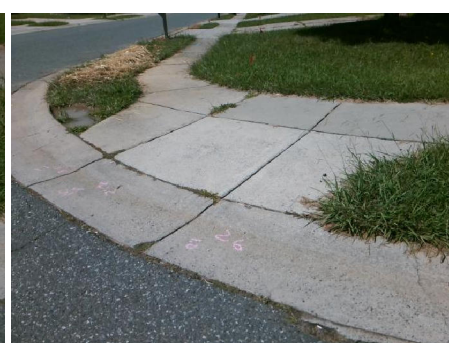
**Not Found, R304.5.1, R304.5.3**

Compliance	Description	Data	Compliance	Description	Data
N/A	Ramp Length (in)	52.5	Yes	Ramp Slope (%)	6.0
No	Ramp Width (in)	47.0	No	Ramp XSlope (%)	4.4
N/A	Flare Type LT	N/A	N/A	Flare Type RT	N/A
N/A	Flare Slope LT (%)	N/A	N/A	Flare Slope RT (%)	N/A
N/A	Flare Traversable LT?	N/A	N/A	Flare Traversable RT?	N/A
N/A	Landing Length (in)	N/A	N/A	DWS Provided?	N/A
N/A	Landing Width (in)	N/A	N/A	DWS Contrast?	N/A
N/A	Landing Slope (%)	N/A	N/A	DWS Length (in)	N/A
N/A	Landing X Slope (%)	N/A	N/A	DWS Full Width?	N/A
N/A	Landing Curb? (Y/N)	N/A	N/A	DWS Offset (in)	N/A
N/A	Shared Landing?	N/A			
N/A	Gutter Ponding?	N/A	N/A	Gutter Slope (%)	N/A
N/A	Gutter Lip Ht (in)	N/A	N/A	Gutter X Slope (%)	N/A
N/A	Painted X Walk1?	No	N/A	Painted X Walk2?	No
	X Walk 1 Direction	To S		X Walk 2 Direction	To E
N/A	X Walk 1 Width (in)	N/A	N/A	X Walk 2 Width (in)	N/A
	X Walk 1 Slope (%)	1.1		X Walk 2 Slope (%)	1.0
	X Walk 1 X Slope (%)	1.6		X Walk 2 X Slope (%)	2.6

N/A	Ramp inside XWalk1?	N/A	N/A	Ramp inside XWalk2?	N/A
	Road Slope (%)	3.3	N/A	Clear Space?	N/A
	Road X Slope (%)	0.2	N/A	Clear Space to XWalk (in)	N/A
N/A	Any Obstructions?	N/A	N/A	Storm Grate/Utility Hazard?	N/A
	Obstruction Type			Storm Grate/Utility Type	
		N/A			N/A
			Yes	Surface Condition? (G/P)	Good

**Remove & Replace Curb Ramp With Two New Directional Ramps or Equivalent.**
