Access Compliance Report

Public Rights-of-Way

(Curb Ramps)

Intersection ID: 54269	Main Street: JOHNSTON_OEHLER_RD	Cross Street: OEHLER_BRIDGE_DR	Location: SW
ADA ID: 88C080511B18	Ramp Type: Perp	Initial Pass/Fail: Fail	Overall Compliance: No
Severity Score: 1.25			
Codes/Mitigation Info/Possible Solution		Field Measurements/Component Compliance

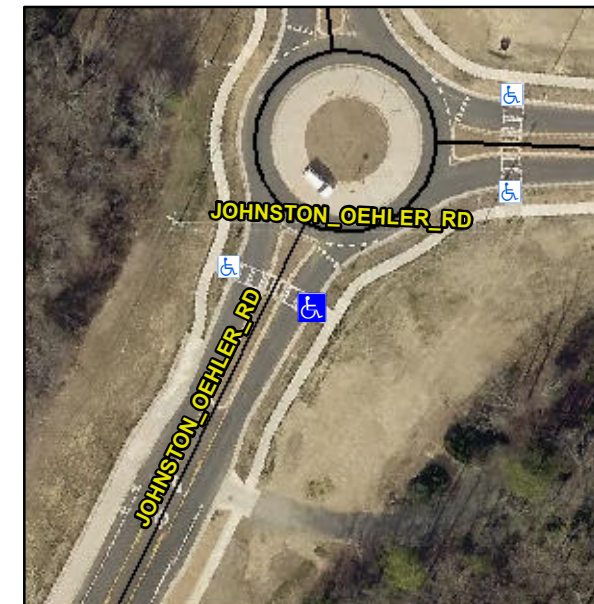
Compliance	Description	Data	Compliance	Description	Data
N/A	Ramp Length (in)	95.5	Yes	Ramp Slope (%)	7.4
Yes	Ramp Width (in)	72.0	No	Ramp XSlope (%)	2.1
N/A	Flare Type LT	N/A	N/A	Flare Type RT	N/A
N/A	Flare Slope LT (%)	N/A	N/A	Flare Slope RT (%)	N/A
N/A	Flare Traversable LT?	N/A	N/A	Flare Traversable RT?	N/A
N/A	Landing Length (in)	N/A	N/A	DWS Provided?	N/A
N/A	Landing Width (in)	N/A	N/A	DWS Contrast?	N/A
N/A	Landing Slope (%)	N/A	N/A	DWS Length (in)	N/A
N/A	Landing X Slope (%)	N/A	N/A	DWS Full Width?	N/A
N/A	Landing Curb? (Y/N)	N/A	N/A	DWS Offset (in)	N/A
N/A	Shared Landing?	N/A			
N/A	Gutter Ponding?	N/A	N/A	Gutter Slope (%)	N/A
N/A	Gutter Lip Ht (in)	N/A	N/A	Gutter X Slope (%)	N/A
N/A	Painted X Walk1?	Yes	N/A	Painted X Walk2?	N/A
	X Walk 1 Direction	To NW		X Walk 2 Direction	N/A
N/A	X Walk 1 Width (in)	104.5	N/A	X Walk 2 Width (in)	N/A
	X Walk 1 Slope (%)	2.8		X Walk 2 Slope (%)	N/A
	X Walk 1 X Slope (%)	2.0		X Walk 2 X Slope (%)	N/A

N/A	Ramp inside XWalk1?	Yes	N/A	Ramp inside XWalk2?	N/A
	Road Slope (%)	N/A	N/A	Clear Space?	N/A
	Road X Slope (%)	N/A	N/A	Clear Space to XWalk (in)	N/A
N/A	Any Obstructions?	N/A	N/A	Storm Grate/Utility Hazard?	N/A
	Obstruction Type			Storm Grate/Utility Type	
		N/A			N/A
			Yes	Surface Condition? (G/P)	Good

Possible Solutions:

Remove & Replace Entire Ramp.
