Access Compliance Report Public Rights-of-Way (Curb Ramps)

Intersection ID: 11524 Main Street: BOYER ST **Cross Street: WILKINSON BV** Location: SE Initial Pass/Fail: Pass **Overall Compliance: No Severity Score:** 0 **ADA ID: 88C6337C4BDD** Ramp Type: Perp

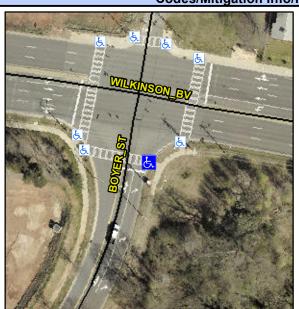
No

BOYER ST Street 1 Name Stop Condition-Street 2 Signal N/A Street 2 Name Stop Condition-Street 1 N/A Possible Solutions: Remove & Replace Detectable Warning System. Surveyor Notes: N/A PROW/ADA: R305.2

Yes Yes Yes Yes N/A N/A Yes Yes N/A N/A Yes Yes Total Cost: 800.00
