Access Compliance Report Public Rights-of-Way (Curb Ramps)

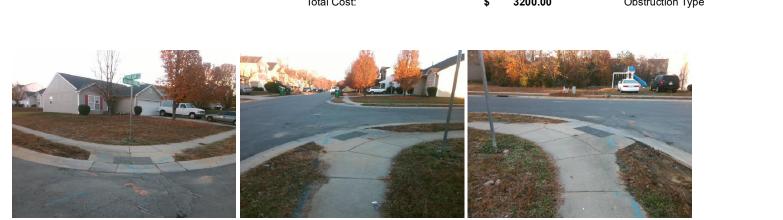
· · · · · · · · · · · · · · · · · · ·									
Intersection ID: 31492	D: 31492 Main Street: CLOVER_GAP_DR			Cross Street: JORDANS_POND_LN				Location:	E
ADA ID: 88CBC00F58E5	8CBC00F58E5 Ramp Type: PerpDiag			Initial Pass/Fail: Fail Overall Compliance: No				o Severity Score:	8.75
Codes/Mitigation Info/Possible Solution				Field Measurements/Component Compliance					
	AND	Possible Solutions:		Compliance Description Date			a Compliance Description		Data
		Remove & Replace Curb Ramp V Two New Directional Ramps or Equivalent.	With	N/A	Ramp Length (in)	49.0	Yes	Ramp Slope (%)	5.3
				No	Ramp Width (in)	44.0	Yes	Ramp XSlope (%)	0.4
				N/A	Flare Type LT	N/A	N/A	Flare Type RT	N/A
				N/A	Flare Slope LT (%)	N/A	N/A	Flare Slope RT (%)	N/A
				N/A	Flare Traversable LT?	N/A	N/A	Flare Traversable RT?	N/A

Stop Condition-Street 1	None				Road Slope (%)	0.4	N/A	Clear Space?	N/A
					Road X Slope (%)	0.9	N/A	Clear Space to XWalk (in)	N/A
				N/A	Any Obstructions?	N/A	N/A	Storm Grate/Utility Hazard?	N/A
		Total Cost: \$	3200.00		Obstruction Type			Storm Grate/Utility Type	
						N/A			N/A
