# Access Compliance Report

## Public Rights-of-Way

### (Curb Ramps)

Intersection ID: 28728	Main Street: ABSON_CT	Cross Street: STEWARTS_CROSSING_DR	Location: N
ADA ID: 88CE1F47F59A	Ramp Type: BlendTrans1	Initial Pass/Fail: Fail	Overall Compliance: No
Severity Score: 21.25			
Codes/Mitigation Info/Possible Solution		Field Measurements/Component Compliance

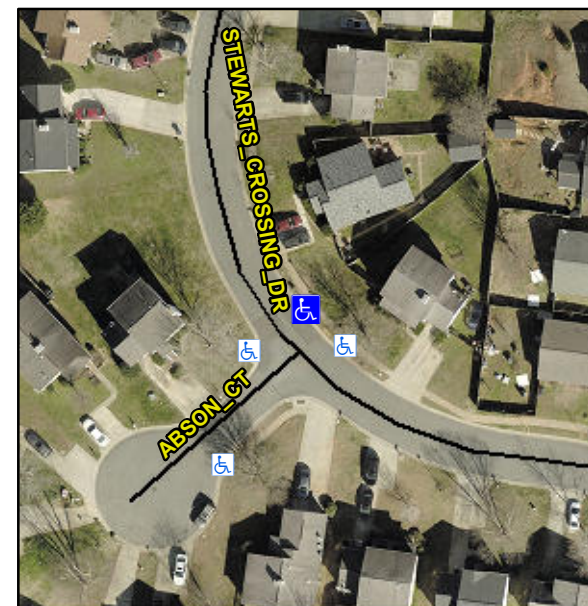
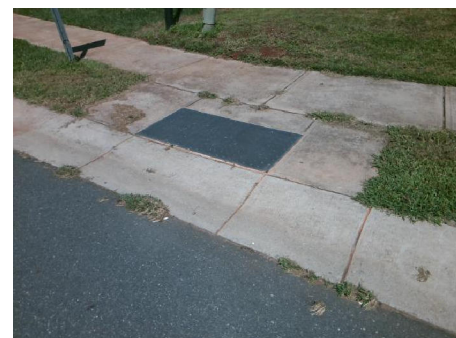
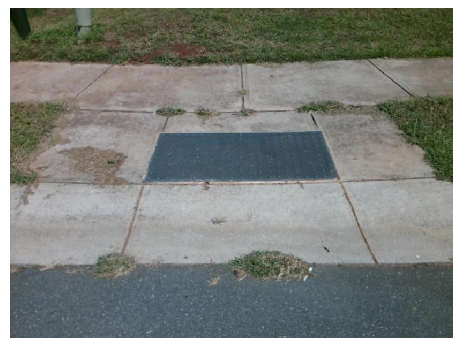
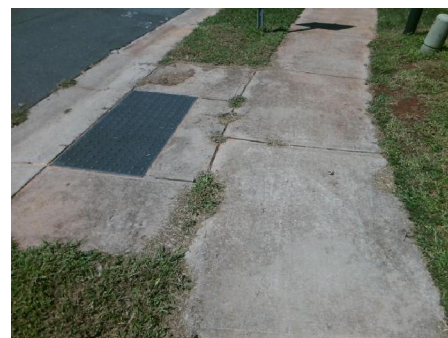
**Not Found, R304.5.1, R304.5.3**

Compliance	Description	Data	Compliance	Description	Data
N/A	Ramp Length (in)	38.5	Yes	BlendTrans Slope (%)	3.7
No	Ramp Width (in)	46.5	No	BlendTrans XSlope (%)	5.5
N/A	Flare Type LT	N/A	N/A	Flare Type RT	N/A
N/A	Flare Slope LT (%)	N/A	N/A	Flare Slope RT (%)	N/A
N/A	Flare Traversable LT?	N/A	N/A	Flare Traversable RT?	N/A
N/A	Landing Length (in)	N/A	N/A	DWS Provided?	N/A
N/A	Landing Width (in)	N/A	N/A	DWS Contrast?	N/A
N/A	Landing Slope (%)	N/A	N/A	DWS Length (in)	N/A
N/A	Landing X Slope (%)	N/A	N/A	DWS Full Width?	N/A
N/A	Landing Curb? (Y/N)	N/A	N/A	DWS Offset (in)	N/A
N/A	Shared Landing?	N/A			
N/A	Gutter Ponding?	N/A	N/A	Gutter Slope (%)	N/A
N/A	Gutter Lip Ht (in)	N/A	N/A	Gutter X Slope (%)	N/A
N/A	Painted X Walk1?	No	N/A	Painted X Walk2?	N/A
	X Walk 1 Direction	To SW		X Walk 2 Direction	N/A
	X Walk 1 Width (in)	N/A		X Walk 2 Width (in)	N/A
	X Walk 1 Slope (%)	2.2		X Walk 2 Slope (%)	N/A
	X Walk 1 X Slope (%)	4.0		X Walk 2 X Slope (%)	N/A

N/A	Ramp inside XWalk1?	N/A	N/A	Ramp inside XWalk2?	N/A
	Road Slope (%)	4.0		Clear Space?	N/A
	Road X Slope (%)	2.2	N/A	Clear Space to XWalk (in)	N/A
N/A	Any Obstructions?	N/A	N/A	Storm Grate/Utility Hazard?	N/A
	Obstruction Type			Storm Grate/Utility Type	
		N/A			N/A
			Yes	Surface Condition? (G/P)	Good
			No	Curb Slope (%)	15.4

**Remove & Replace Curb Ramp With Two New Directional Ramps or Equivalent.**
