Access Compliance Report Public Rights-of-Way (Curb Ramps)

Intersection ID: N/AMain Street:WILKINSON_BVCross Street: N/ALocation:SEADA ID: 88CFD61DE5E1Ramp Type:Directional2Initial Pass/Fail: FailOverall Compliance: NoSeverity Score:0.25

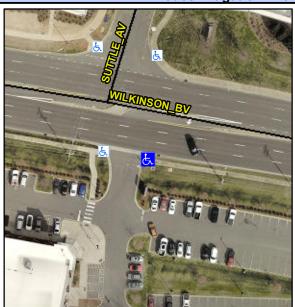
Field Measurements/Component Compliance						
Compl	iance Description	Data	Comp	liance Description	Data	
N/A	Ramp Length (in)	66.0	N/A	Grade Break?	N/A	
Yes	Ramp Width (in)	56.0	N/A	Grade Break Slope (%)	0.0	
Yes	Ramp Slope (%)	1.3	N/A	Grade Break XSlope (%)	0.0	
No	Ramp XSlope (%)	4.6				
N/A	Flare Type LT	N/A	N/A	Flare Type RT	N/A	
N/A	Flare Slope LT (%)	N/A	N/A	Flare Slope RT (%)	0.0	
N/A	Flare Traversable LT?	No	N/A	Flare Traversable RT?	No	
No	Landing Length (in)	0.0	N/A	DWS Provided?	N/A	
No	Landing Width (in)	0.0	N/A	DWS Contrast?	N/A	
No	Landing Slope (%)	0.0	N/A	DWS Length (in)	N/A	
No	Landing X Slope (%)	0.0	N/A	DWS Full Width?	N/A	
N/A	Landing Curb? (Y/N)	N/A	N/A	DWS Offset LT (in)	N/A	
N/A	Shared Landing?	N/A	N/A	DWS Offset RT (in)	N/A	
Yes	Gutter Ponding?	0.0	No	Gutter Slope (%)	N/A	
No	Gutter Lip Ht (in)	0.0	No	Gutter X Slope (%)	N/A	
N/A	Painted X Walk1?	No		Road Slope (%)	4.7	
	X Walk 1 Direction	To SW		Road X Slope (%)	4.5

X Walk 1 Width (in)	N/A		Clear Space?	N/A	
	X Walk 1 Slope (%)	4.7	N/A	Clear Space to XWalk (in)	N/A	
	X Walk 1 X Slope (%)	4.5	Yes	Storm Grate/Utility Hazard?	N/A	
N/A	Ramp inside XWalk1?	N/A		Storm Grate/Utility Type		
Yes	Any Obstructions?	N/A			N/A	
	Obstruction Type		Yes	Surface Condition? (G/P)	Good	
		N/A	N/A	Curb Slope (%)	4.3

Possible Solution	
Possible Solutions:	Compli
Remove & Replace Entire Ramp.	N/A
Remove & Replace Gutter.	Yes
	Yes
	No
	N/A
	N/A
Surveyor Notes:	N/A
N/A	No
	No
	No
	No
PROW/ADA:	N/A
R304.5.3, R304.2.1, R304.2.2-Perp,	N/A
R304.3.2-Para, R302.7.2, R304.5.4	Yes
	No
	N/A
	N/A
