Access Compliance Report

Public Rights-of-Way

(Curb Ramps)

Intersection ID: 11099	Main Street: DENSON_PL	Cross Street: TIPPERARY_PL	Location: N
ADA ID: 88D15DF6E9CD	Ramp Type: Para	Initial Pass/Fail: Fail	Overall Compliance: No
Codes/Mitigation Info/Possible Solution		Field Measurements/Component Compliance

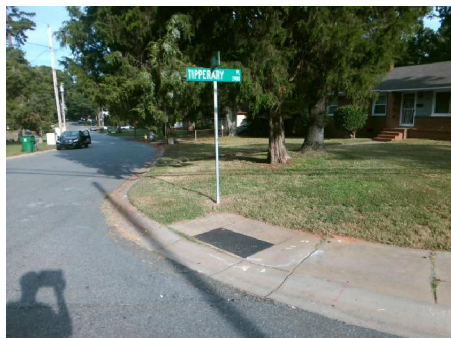
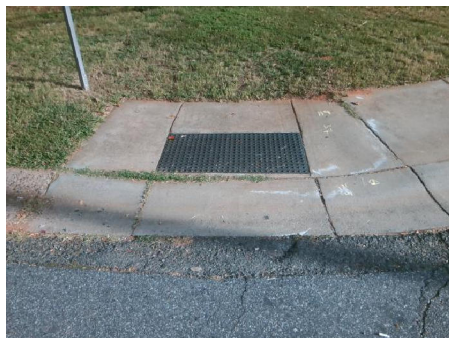
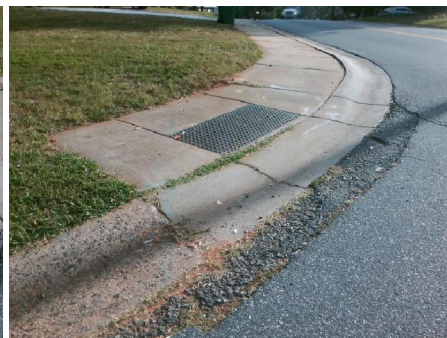
LT RP < 5%

Compliance	Description	Data	Compliance	Description	Data
N/A	Ramp Length LT (in)	29.0	N/A	Ramp Length RT (in)	20.0
Yes	Ramp Width LT (in)	52.0	Yes	Ramp Width RT (in)	52.0
Yes	Ramp Slope LT (%)	0.9	No	Ramp Slope RT (%)	11.4
Yes	Ramp XSlope LT (%)	1.9	No	Ramp XSlope RT (%)	3.7
N/A	Landing Length (in)	N/A	N/A	DWS Provided?	N/A
N/A	Landing Width (in)	N/A	N/A	DWS Contrast?	N/A
N/A	Landing Slope (%)	N/A	N/A	DWS Length (in)	N/A
N/A	Landing X Slope (%)	N/A	N/A	DWS Full Width?	N/A
N/A	Landing Curb? (Y/N)	N/A	N/A	DWS Offset (in)	N/A
N/A	Shared Landing?	N/A			
N/A	Gutter Ponding?	N/A	N/A	Gutter Slope (%)	N/A
N/A	Gutter Lip Ht (in)	N/A	N/A	Gutter X Slope (%)	N/A
N/A	Painted X Walk1?	No	N/A	Painted X Walk2?	N/A
	X Walk 1 Direction	To SW		X Walk 2 Direction	N/A
N/A	X Walk 1 Width (in)	N/A	N/A	X Walk 2 Width (in)	N/A
	X Walk 1 Slope (%)	3.5		X Walk 2 Slope (%)	N/A
	X Walk 1 X Slope (%)	1.0		X Walk 2 X Slope (%)	N/A
N/A	Ramp inside XWalk1?	N/A	N/A	Ramp inside XWalk2?	N/A

Road Slope (%)	N/A	N/A	Clear Space?	N/A
	Road X Slope (%)	N/A	N/A	Clear Space to XWalk (in)	N/A
N/A	Any Obstructions?	N/A	N/A	Storm Grate/Utility Hazard?	N/A
	Obstruction Type			Storm Grate/Utility Type	
		N/A			N/A
			Yes	Surface Condition? (G/P)	Good
			N/A	Curb Slope (%)	20.0

Possible Solutions:

Remove & Replace Entire Ramp.
