Access Compliance Report

Public Rights-of-Way

(Curb Ramps)

Intersection ID: 6499	Main Street: HOYT_HINSON_RD	Cross Street: NEVIN_RD	Location: NW
ADA ID: 88D78D585E73	Ramp Type: Directional1	Initial Pass/Fail: Fail	Overall Compliance: No
		Severity Score: 12.5

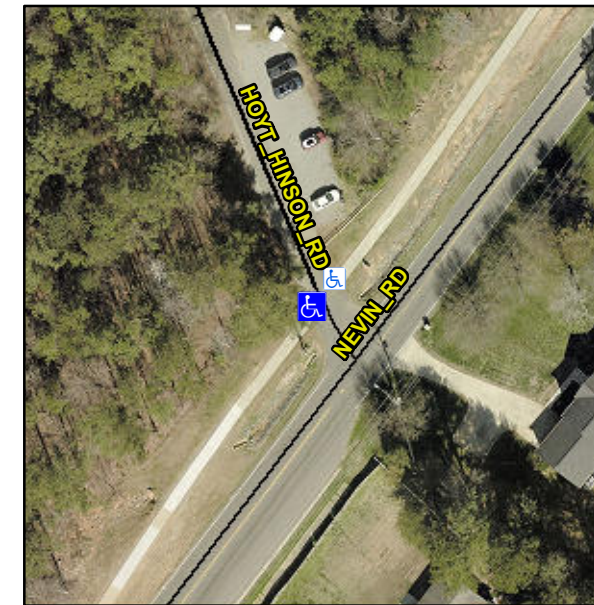
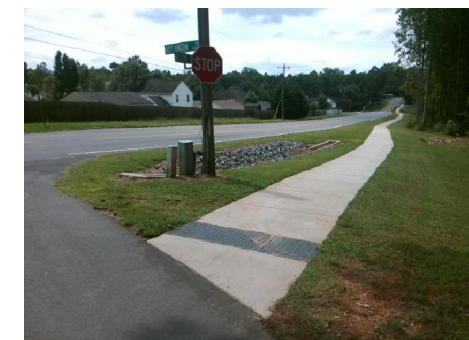
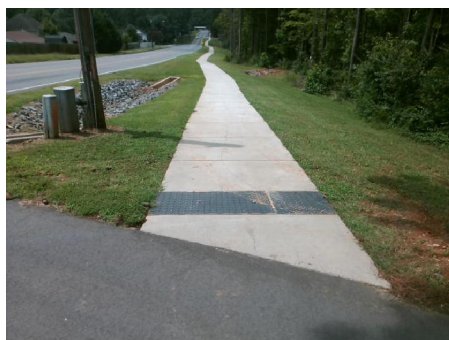
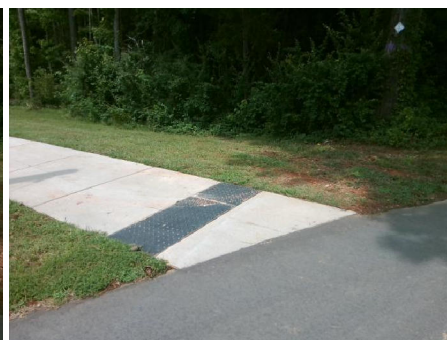
Compliance	Description	Data	Compliance	Description	Data
N/A	Ramp Length (in)	72.5	N/A	Grade Break?	N/A
Yes	Ramp Width (in)	72.0	N/A	Grade Break Slope (%)	0.0
No	Ramp Slope (%)	9.8	N/A	Grade Break XSlope (%)	0.0
Yes	Ramp XSlope (%)	0.6			
N/A	Flare Type LT	N/A	N/A	Flare Type RT	N/A
N/A	Flare Slope LT (%)	N/A	N/A	Flare Slope RT (%)	0.0
N/A	Flare Traversable LT?	N/A	N/A	Flare Traversable RT?	N/A
N/A	Landing Length (in)	0.0	N/A	DWS Provided?	N/A
N/A	Landing Width (in)	0.0	N/A	DWS Contrast?	N/A
N/A	Landing Slope (%)	0.0	N/A	DWS Length (in)	N/A
N/A	Landing X Slope (%)	0.0	N/A	DWS Full Width?	N/A
N/A	Landing Curb? (Y/N)	N/A	N/A	DWS Offset LT (in)	N/A
N/A	Shared Landing?	N/A	N/A	DWS Offset RT (in)	N/A
N/A	Gutter Ponding?	0.0	N/A	Gutter Slope (%)	N/A
N/A	Gutter Lip Ht (in)	0.0	N/A	Gutter X Slope (%)	N/A
N/A	Painted X Walk1?	No		Road Slope (%)	7.9
	X Walk 1 Direction	To N		Road X Slope (%)	0.2
	X Walk 1 Width (in)	N/A		Clear Space?	N/A

X Walk 1 Slope (%)	7.9	N/A	Clear Space to XWalk (in)	N/A
	X Walk 1 X Slope (%)	0.2	N/A	Storm Grate/Utility Hazard?	N/A
N/A	Ramp inside XWalk1?	N/A		Storm Grate/Utility Type	
N/A	Any Obstructions?	N/A			N/A
	Obstruction Type		Yes	Surface Condition? (G/P)	Good
			N/A	Curb Slope (%)	N/A

Remove & Replace Entire Ramp.
