Access Compliance Report

Public Rights-of-Way

(Curb Ramps)

Intersection ID: 30240	Main Street: OLD_PLANK_RD	Cross Street: MCGINN GROVE_DR	Location:	N
ADA ID: 88DB6DE997C8	Ramp Type: Perp	Initial Pass/Fail: Fail	Overall Compliance: No	Severity Score: 33.75
Codes/Mitigation Info/Possible Solution		Field Measurements/Component Compliance

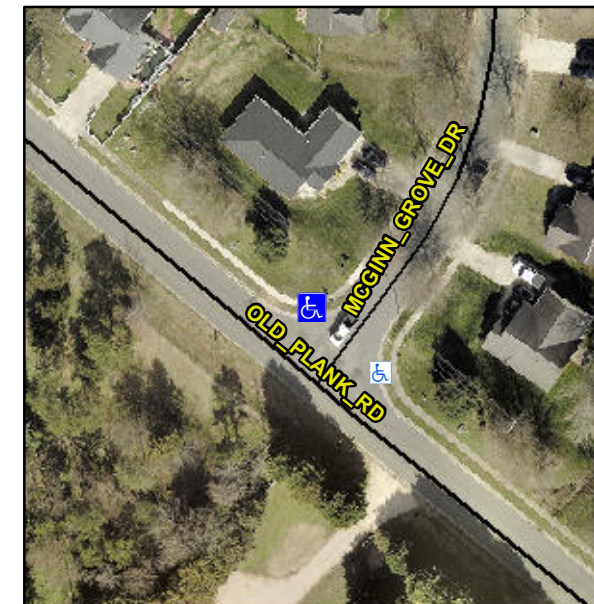
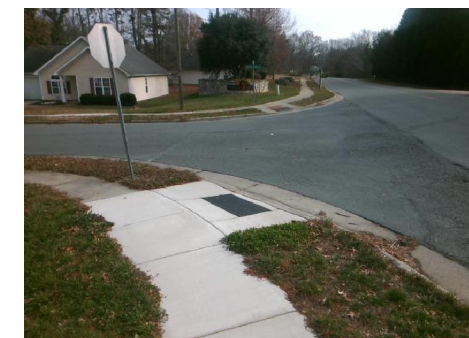
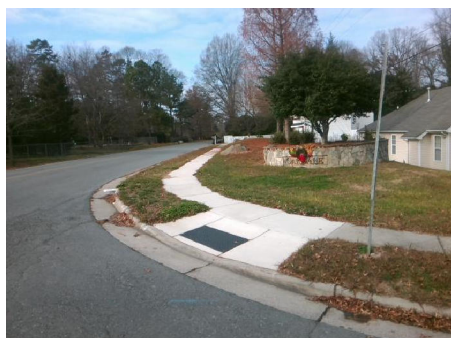
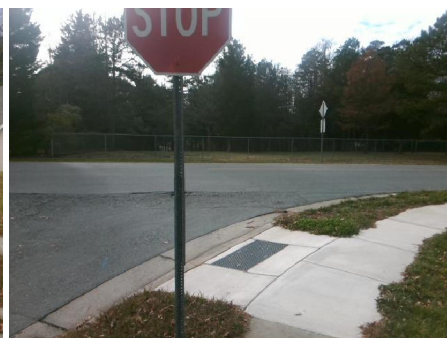
Not Found, R304.5.1, R304.2.2, R304.5.3

Compliance	Description	Data	Compliance	Description	Data
N/A	Ramp Length (in)	49.5	No	Ramp Slope (%)	11.9
No	Ramp Width (in)	47.0	No	Ramp XSlope (%)	5.3
N/A	Flare Type LT	N/A	N/A	Flare Type RT	N/A
N/A	Flare Slope LT (%)	N/A	N/A	Flare Slope RT (%)	N/A
N/A	Flare Traversable LT?	N/A	N/A	Flare Traversable RT?	N/A
N/A	Landing Length (in)	N/A	N/A	DWS Provided?	N/A
N/A	Landing Width (in)	N/A	N/A	DWS Contrast?	N/A
N/A	Landing Slope (%)	N/A	N/A	DWS Length (in)	N/A
N/A	Landing X Slope (%)	N/A	N/A	DWS Full Width?	N/A
N/A	Landing Curb? (Y/N)	N/A	N/A	DWS Offset (in)	N/A
N/A	Shared Landing?	N/A			
N/A	Gutter Ponding?	N/A	N/A	Gutter Slope (%)	N/A
N/A	Gutter Lip Ht (in)	N/A	N/A	Gutter X Slope (%)	N/A
N/A	Painted X Walk1?	No	N/A	Painted X Walk2?	N/A
	X Walk 1 Direction	To SE		X Walk 2 Direction	N/A
N/A	X Walk 1 Width (in)	N/A	N/A	X Walk 2 Width (in)	N/A
	X Walk 1 Slope (%)	0.9		X Walk 2 Slope (%)	N/A
	X Walk 1 X Slope (%)	8.1		X Walk 2 X Slope (%)	N/A

N/A	Ramp inside XWalk1?	N/A	N/A	Ramp inside XWalk2?	N/A
	Road Slope (%)	N/A	N/A	Clear Space?	N/A
	Road X Slope (%)	N/A	N/A	Clear Space to XWalk (in)	N/A
N/A	Any Obstructions?	N/A	N/A	Storm Grate/Utility Hazard?	N/A
	Obstruction Type			Storm Grate/Utility Type	
		N/A			N/A
			Yes	Surface Condition? (G/P)	Good

Remove & Replace Entire Ramp.
