# Access Compliance Report

## Public Rights-of-Way

### (Curb Ramps)

Intersection ID: N/A	Main Street: COPPER_WY	Cross Street: N/A	Location: NE
ADA ID: 88E29C891094	Ramp Type: PerpDiag	Initial Pass/Fail: Fail	Overall Compliance: No
		Severity Score: 10

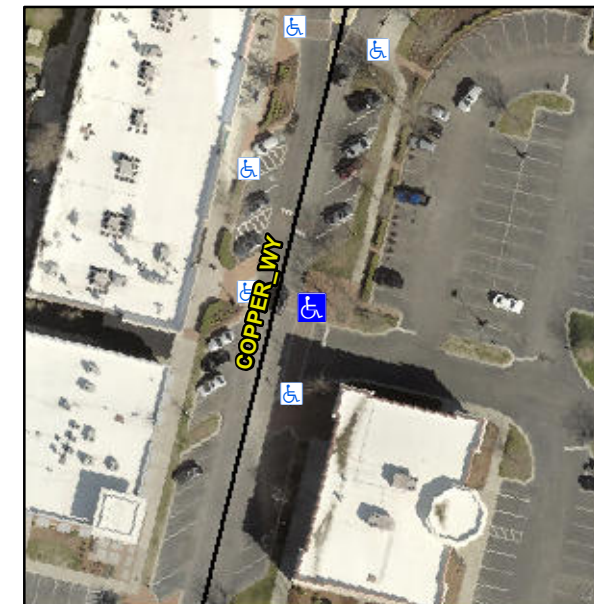
**Not Found, R304.5.1, R304.5.3**

Compliance	Description	Data	Compliance	Description	Data
N/A	Ramp Length (in)	71.0	Yes	Ramp Slope (%)	7.8
No	Ramp Width (in)	37.0	No	Ramp XSlope (%)	3.3
N/A	Flare Type LT	N/A	N/A	Flare Type RT	N/A
N/A	Flare Slope LT (%)	N/A	N/A	Flare Slope RT (%)	N/A
N/A	Flare Traversable LT?	N/A	N/A	Flare Traversable RT?	N/A
N/A	Landing Length (in)	N/A	N/A	DWS Provided?	N/A
N/A	Landing Width (in)	N/A	N/A	DWS Contrast?	N/A
N/A	Landing Slope (%)	N/A	N/A	DWS Length (in)	N/A
N/A	Landing X Slope (%)	N/A	N/A	DWS Full Width?	N/A
N/A	Landing Curb? (Y/N)	N/A	N/A	DWS Offset (in)	N/A
N/A	Shared Landing?	N/A			
N/A	Gutter Ponding?	N/A	N/A	Gutter Slope (%)	N/A
N/A	Gutter Lip Ht (in)	N/A	N/A	Gutter X Slope (%)	N/A
N/A	Painted X Walk1?	Yes	N/A	Painted X Walk2?	Yes
	X Walk 1 Direction	To NW		X Walk 2 Direction	To SW
N/A	X Walk 1 Width (in)	101.0	N/A	X Walk 2 Width (in)	101.0
	X Walk 1 Slope (%)	0.9		X Walk 2 Slope (%)	1.0
	X Walk 1 X Slope (%)	1.1		X Walk 2 X Slope (%)	1.8

N/A	Ramp inside XWalk1?	Yes	N/A	Ramp inside XWalk2?	Yes
	Road Slope (%)	1.9	N/A	Clear Space?	N/A
	Road X Slope (%)	1.5	N/A	Clear Space to XWalk (in)	N/A
N/A	Any Obstructions?	N/A	N/A	Storm Grate/Utility Hazard?	N/A
	Obstruction Type			Storm Grate/Utility Type	
		N/A			N/A
		Yes		Surface Condition? (G/P)	Good

**Remove & Replace Curb Ramp With Two New Directional Ramps or Equivalent.**
