# Access Compliance Report

## Public Rights-of-Way

### (Curb Ramps)

| Intersection ID: 15676 | Main Street: CHEROKEE_PL | Cross Street: CHEROKEE_RD | Location: SW |

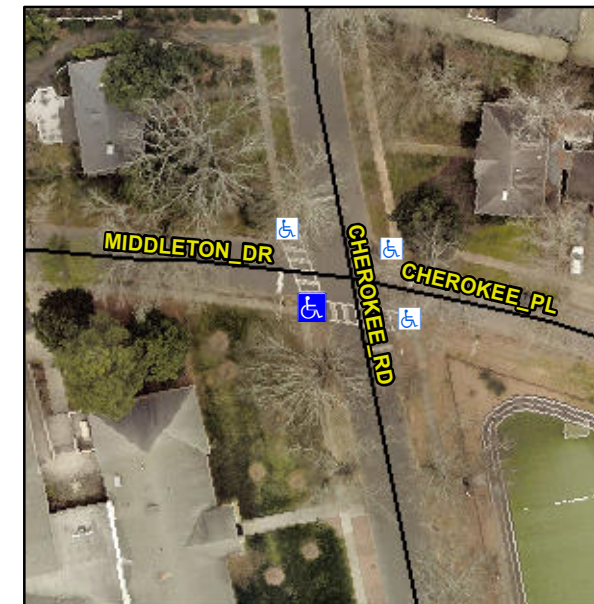
| ADA ID: 88E90B1A01F1 | Ramp Type: PerpDiag | Initial Pass/Fail: Fail | Overall Compliance: No |

**Not Found, R304.2.2**

| Compliance | Description | Data | Compliance | Description | Data |
|---|---|---|---|---|---|
| N/A | Ramp Length (in) | 99.0 | No | Ramp Slope (%) | 9.0 |

**Remove & Replace Curb Ramp With Two New Directional Ramps or Equivalent.**

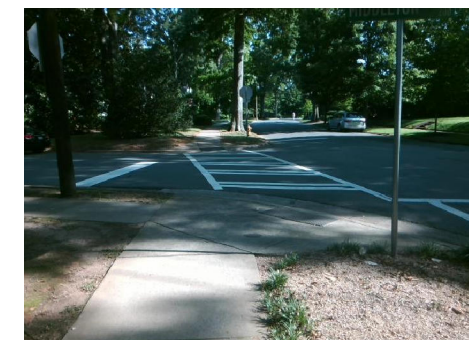
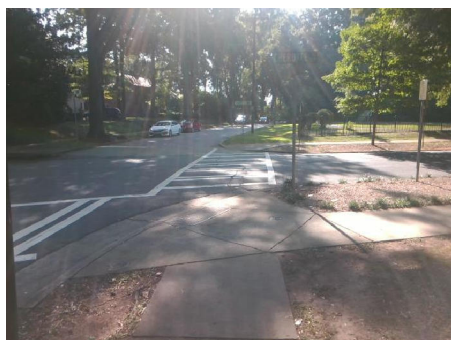
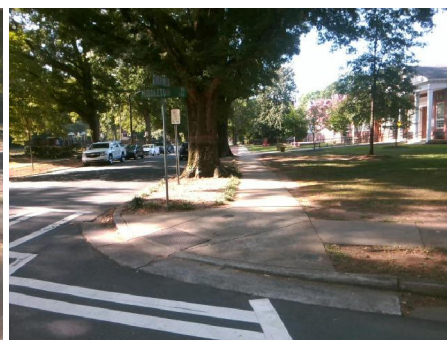
| Compliance | Description | Data | Compliance | Description | Data |
|---|---|---|---|---|---|
| Yes | Ramp Width (in) | 50.0 | Yes | Ramp XSlope (%) | 1.9 |
