# Access Compliance Report

## Public Rights-of-Way

### (Curb Ramps)

Intersection ID: 19242	Main Street: SHARON_LN	Cross Street: SHARON_RD	Location: SW
ADA ID: 88E9333AA276	Ramp Type: Para	Initial Pass/Fail: Fail	Overall Compliance: No
Severity Score: 13.75			
Codes/Mitigation Info/Possible Solution		Field Measurements/Component Compliance

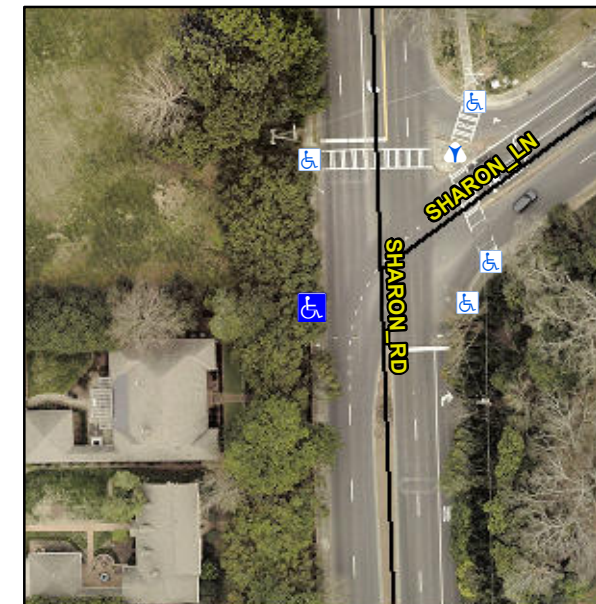
**ASP LIP 0.5, RT RP < 5%**

**R304.3.2, R304.5.3**

Compliance	Description	Data	Compliance	Description	Data
N/A	Ramp Length LT (in)	88.0	N/A	Ramp Length RT (in)	96.0
Yes	Ramp Width LT (in)	62.0	Yes	Ramp Width RT (in)	62.0
No	Ramp Slope LT (%)	10.6	Yes	Ramp Slope RT (%)	3.1
No	Ramp XSlope LT (%)	4.9	No	Ramp XSlope RT (%)	3.1
N/A	Landing Length (in)	N/A	N/A	DWS Provided?	N/A
N/A	Landing Width (in)	N/A	N/A	DWS Contrast?	N/A
N/A	Landing Slope (%)	N/A	N/A	DWS Length (in)	N/A
N/A	Landing X Slope (%)	N/A	N/A	DWS Full Width?	N/A
N/A	Landing Curb? (Y/N)	N/A	N/A	DWS Offset (in)	N/A
N/A	Shared Landing?	N/A			
N/A	Gutter Ponding?	N/A	N/A	Gutter Slope (%)	N/A
N/A	Gutter Lip Ht (in)	1.0	N/A	Gutter X Slope (%)	N/A
N/A	Painted X Walk1?	No	N/A	Painted X Walk2?	N/A
	X Walk 1 Direction	To E		X Walk 2 Direction	N/A
N/A	X Walk 1 Width (in)	N/A	N/A	X Walk 2 Width (in)	N/A
	X Walk 1 Slope (%)	2.2		X Walk 2 Slope (%)	N/A
	X Walk 1 X Slope (%)	1.4		X Walk 2 X Slope (%)	N/A
N/A	Ramp inside XWalk1?	N/A	N/A	Ramp inside XWalk2?	N/A

Road Slope (%)	N/A	N/A	Clear Space?	N/A
	Road X Slope (%)	N/A	N/A	Clear Space to XWalk (in)	N/A
N/A	Any Obstructions?	N/A	N/A	Storm Grate/Utility Hazard?	N/A
	Obstruction Type			Storm Grate/Utility Type	
		N/A			N/A
			Yes	Surface Condition? (G/P)	Good
			N/A	Curb Slope (%)	8.1

Possible Solutions:

**Remove & Replace Entire Ramp.**
