Access Compliance Report

Public Rights-of-Way

(Curb Ramps)

Intersection ID: 13408	Main Street: COMMONWEALTH_AV	Cross Street: THE_PLAZA	Location: S
ADA ID: 88ED5739A318	Ramp Type: Directional1	Initial Pass/Fail: Fail	Overall Compliance: No
Severity Score: 12.5			
Codes/Mitigation Info/Possible Solution		Field Measurements/Component Compliance

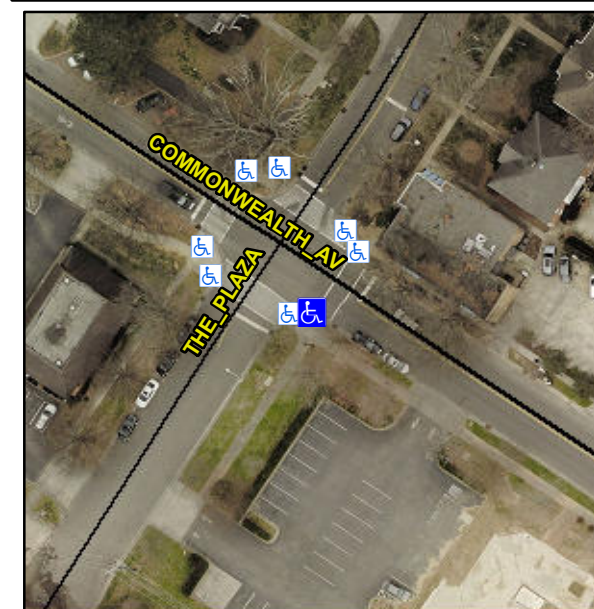
Compliance	Description	Data	Compliance	Description	Data
N/A	Ramp Length (in)	55.5	N/A	Grade Break?	N/A
Yes	Ramp Width (in)	67.0	N/A	Grade Break Slope (%)	0.0
No	Ramp Slope (%)	11.4	N/A	Grade Break XSlope (%)	0.0
Yes	Ramp XSlope (%)	1.3			
N/A	Flare Type LT	N/A	N/A	Flare Type RT	N/A
N/A	Flare Slope LT (%)	N/A	N/A	Flare Slope RT (%)	0.0
N/A	Flare Traversable LT?	N/A	N/A	Flare Traversable RT?	N/A
N/A	Landing Length (in)	0.0	N/A	DWS Provided?	N/A
N/A	Landing Width (in)	0.0	N/A	DWS Contrast?	N/A
N/A	Landing Slope (%)	0.0	N/A	DWS Length (in)	N/A
N/A	Landing X Slope (%)	0.0	N/A	DWS Full Width?	N/A
N/A	Landing Curb? (Y/N)	N/A	N/A	DWS Offset LT (in)	N/A
N/A	Shared Landing?	N/A	N/A	DWS Offset RT (in)	N/A
N/A	Gutter Ponding?	0.0	N/A	Gutter Slope (%)	N/A
N/A	Gutter Lip Ht (in)	0.0	N/A	Gutter X Slope (%)	N/A
N/A	Painted X Walk1?	Yes		Road Slope (%)	6.7
	X Walk 1 Direction	To NE		Road X Slope (%)	2.0
	X Walk 1 Width (in)	110.5		Clear Space?	N/A

X Walk 1 Slope (%)	6.7	N/A	Clear Space to XWalk (in)	N/A
	X Walk 1 X Slope (%)	2.0	N/A	Storm Grate/Utility Hazard?	N/A
N/A	Ramp inside XWalk1?	Yes		Storm Grate/Utility Type	
N/A	Any Obstructions?	N/A			N/A
	Obstruction Type		Yes	Surface Condition? (G/P)	Good
			N/A	Curb Slope (%)	24.0

Possible Solutions:

Remove & Replace Entire Ramp.
