Access Compliance Report Public Rights-of-Way (Curb Ramps)

| Intersection ID: 10625 | : 10625 Main Street: ACADEMY_ST | | | Cross | Street: | MEADOW_LN | Location: | NE | | | |
| ADA ID: 88EE906444AB Ramp Type: Perp | | | | Initial I | Initial Pass/Fail: Fail Overall Compliance: No | | | | o Severity Score: | 33.75 | |

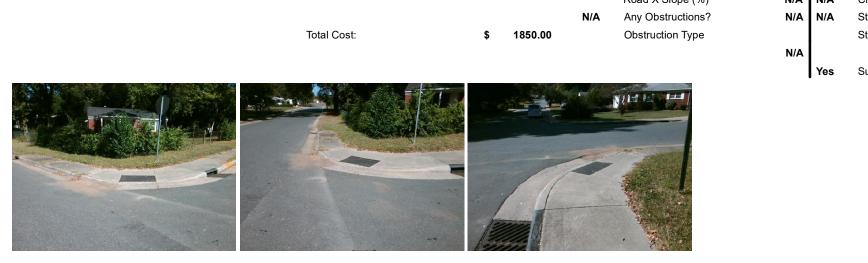
| Intersection ID: 10625 | : 10625 Main Street: ACADEMY_ST | | | Cross | Street: | MEADOW_LN | Location: | NE | | | |
|---|---|---|---|---|--|---|---|---|---|---|--|
| | A STATE | Remove & Replace | e Entire Ramp |). | N/A | Ramp Length (in) | 59.5 | No | Ramp Slope (%) | 8.5 | |
| | No. of the second se | | | | No | Ramp Width (in) | 47.0 | No | Ramp XSlope (%) | 5.2 | |
| 19 A. 1 | | Not Found, R304.5 | 5.1. R304.2.2. | | N/A | Gutter Lip Ht (in) | N/A | N/A | Gutter X Slope (%) | N/A | |
| | | R304.5.3 | ,, | | N/A | Painted X Walk1? | No | N/A | Painted X Walk2? | N/A | |

| Intersection ID: 10625 | : 10625 Main Street: ACADEMY_ST | | | Cross | Street: | MEADOW_LN | Location: | NE | | | |
|---|---|---|---|---|--|---|---|---|---|---|--|
| | | Total Cost: | \$ | 1850.00 | | Obstruction Type | | | Storm Grate/Utility Type | | |
