Access Compliance Report Public Rights-of-Way (Curb Ramps)

Intersection ID: 31204 Main Street: GOODLOE DR **Cross Street: SANDPINES LN** Location: S ADA ID: 88EED95A1D17 Ramp Type: PerpDiag Initial Pass/Fail: Fail **Overall Compliance: No Severity Score:** 10

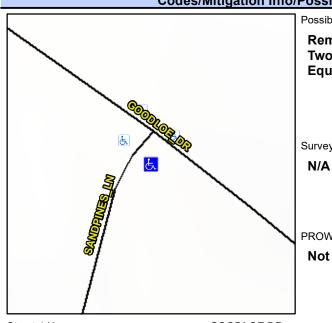
Not Found, R304.5.1, R304.5.3

Data	Compliance Description		Data
N/A	Ramp Length (in)	48.0	Yes	Ramp Slope (%)	7.6
No	Ramp Width (in)	47.0	No	Ramp XSlope (%)	4.0
N/A	Flare Type LT	N/A	N/A	Flare Type RT	N/A
N/A	Flare Slope LT (%)	N/A	N/A	Flare Slope RT (%)	N/A
N/A	Flare Traversable LT?	N/A	N/A	Flare Traversable RT?	N/A
N/A	Landing Length (in)	N/A	N/A	DWS Provided?	N/A
N/A	Landing Width (in)	N/A	N/A	DWS Contrast?	N/A
N/A	Landing Slope (%)	N/A	N/A	DWS Length (in)	N/A
N/A	Landing X Slope (%)	N/A	N/A	DWS Full Width?	N/A
N/A	Landing Curb? (Y/N)	N/A	N/A	DWS Offset (in)	N/A
N/A	Shared Landing?	N/A			
N/A	Gutter Ponding?	N/A	N/A	Gutter Slope (%)	N/A
N/A	Gutter Lip Ht (in)	N/A	N/A	Gutter X Slope (%)	N/A
N/A	Painted X Walk1?	No	N/A	Painted X Walk2?	No
	X Walk 1 Direction	To NE		X Walk 2 Direction	To NW
N/A	X Walk 1 Width (in)	N/A	N/A	X Walk 2 Width (in)	N/A
	X Walk 1 Slope (%)	1.2		X Walk 2 Slope (%)	1.5
	X Walk 1 X Slope (%)	2.7		X Walk 2 X Slope (%)	3.4

N/A	Ramp inside XWalk1?	N/A	N/A	Ramp inside XWalk2?	N/A
	Road Slope (%)	1.2	N/A	Clear Space?	N/A
	Road X Slope (%)	8.0	N/A	Clear Space to XWalk (in)	N/A
N/A	Any Obstructions?	N/A	N/A	Storm Grate/Utility Hazard?	N/A
	Obstruction Type			Storm Grate/Utility Type	
		N/A			N/A
			l

Street 1 Name Stop Condition-Street 2 Street 2 Name Stop Condition-Street 1 Possible Solutions: Remove & Replace Curb Ramp With **Two New Directional Ramps or** Equivalent. Surveyor Notes:
