Access Compliance Report

Public Rights-of-Way

(Curb Ramps)

Intersection ID: 32079	Main Street: ASHGROVE LN	Cross Street: KEEGAN WY	Location:	E
ADA ID: 88F00560EAC6	Ramp Type: PerpDiag	Initial Pass/Fail: Fail	Overall Compliance: No	Severity Score: 8.75
Codes/Mitigation Info/Possible Solution		Field Measurements/Component Compliance

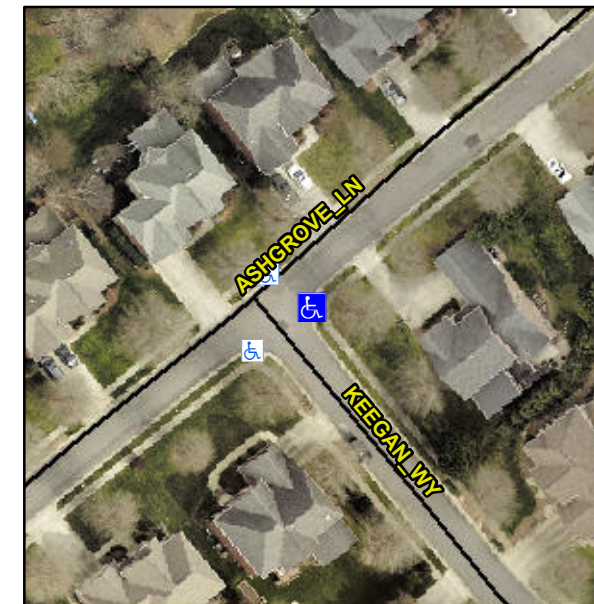
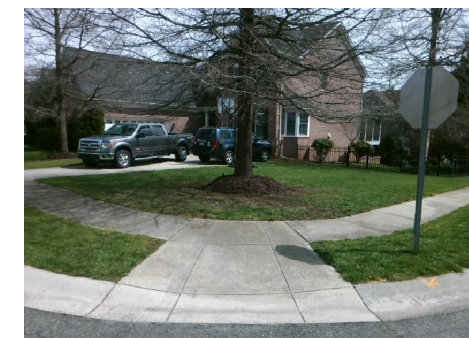
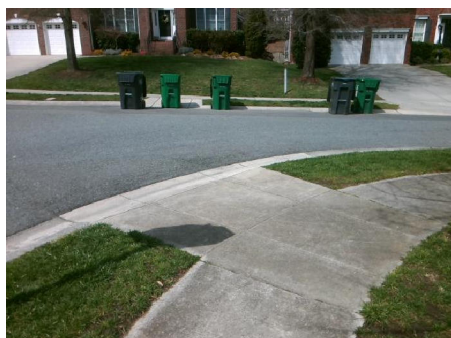
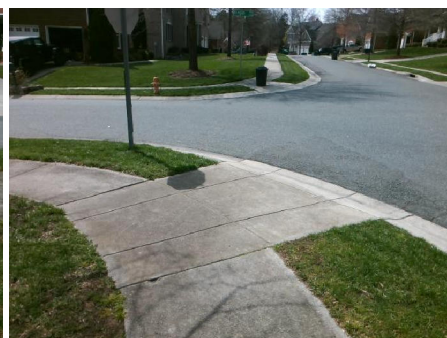
Not Found, R304.5.1

Compliance	Description	Data	Compliance	Description	Data
N/A	Ramp Length (in)	53.0	Yes	Ramp Slope (%)	5.1
No	Ramp Width (in)	36.0	Yes	Ramp XSlope (%)	0.2
N/A	Flare Type LT	N/A	N/A	Flare Type RT	N/A
N/A	Flare Slope LT (%)	N/A	N/A	Flare Slope RT (%)	N/A
N/A	Flare Traversable LT?	N/A	N/A	Flare Traversable RT?	N/A
N/A	Landing Length (in)	N/A	N/A	DWS Provided?	N/A
N/A	Landing Width (in)	N/A	N/A	DWS Contrast?	N/A
N/A	Landing Slope (%)	N/A	N/A	DWS Length (in)	N/A
N/A	Landing X Slope (%)	N/A	N/A	DWS Full Width?	N/A
N/A	Landing Curb? (Y/N)	N/A	N/A	DWS Offset (in)	N/A
N/A	Shared Landing?	N/A			
N/A	Gutter Ponding?	N/A	N/A	Gutter Slope (%)	N/A
N/A	Gutter Lip Ht (in)	N/A	N/A	Gutter X Slope (%)	N/A
N/A	Painted X Walk1?	No	N/A	Painted X Walk2?	No
	X Walk 1 Direction	To NW		X Walk 2 Direction	To SW
N/A	X Walk 1 Width (in)	N/A	N/A	X Walk 2 Width (in)	N/A
	X Walk 1 Slope (%)	5.4		X Walk 2 Slope (%)	4.1
	X Walk 1 X Slope (%)	3.3		X Walk 2 X Slope (%)	5.5

N/A	Ramp inside XWalk1?	N/A	N/A	Ramp inside XWalk2?	N/A
	Road Slope (%)	1.3	N/A	Clear Space?	N/A
	Road X Slope (%)	7.3	N/A	Clear Space to XWalk (in)	N/A
N/A	Any Obstructions?	N/A	N/A	Storm Grate/Utility Hazard?	N/A
	Obstruction Type			Storm Grate/Utility Type	
		N/A			N/A
			Yes	Surface Condition? (G/P)	Good

Remove & Replace Curb Ramp With Two New Directional Ramps or Equivalent.
