# Access Compliance Report

## Public Rights-of-Way

### (Curb Ramps)

| Intersection ID: 24333 | Main Street: BIRNEN_DR | Cross Street: GLISSON_CT | Location: NE |

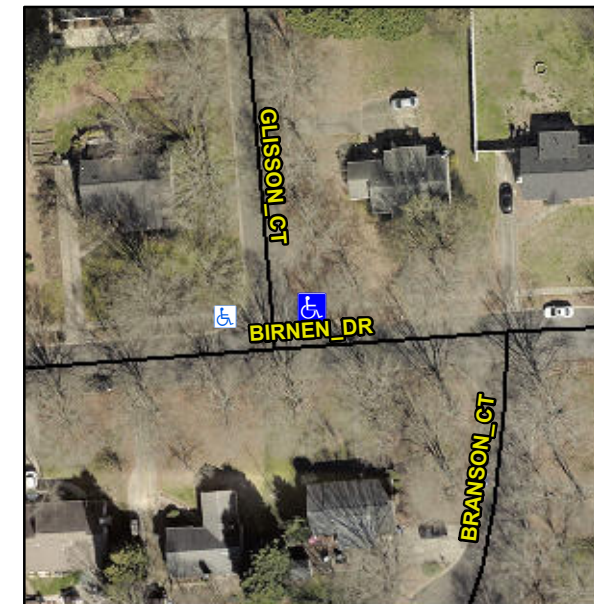
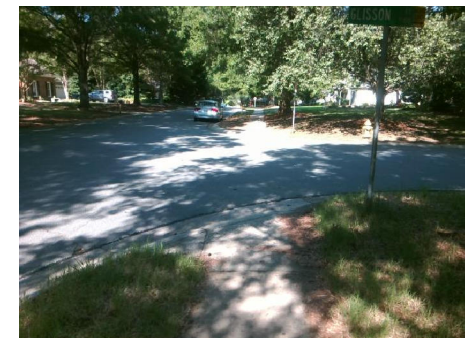
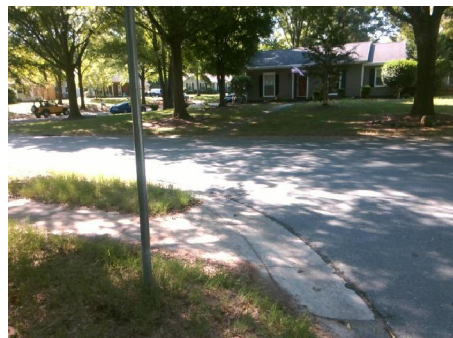
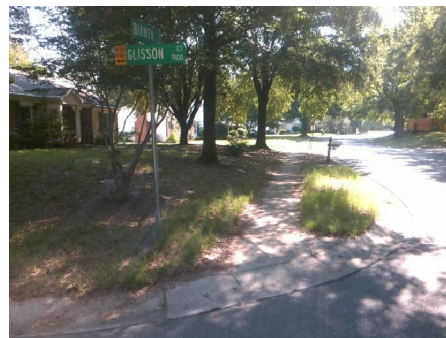
| ADA ID: 88F3FACA3B9B | Ramp Type: BlendTrans1 | Initial Pass/Fail: Pass | Overall Compliance: No |
| | | Severity Score: 10 | |

**Not Found, R304.5.3, R305**

| Compliance | Description | Data | Compliance | Description | Data |
|---|---|---|---|---|---|
| Yes | Landing Length (in) | 57.0 | No | DWS Provided? | No |
| No | Landing X Slope (%) | 2.2 | N/A | DWS Full Width? | No |
| | | | No | Curb Slope (%) | 18.0 |

**Remove & Replace Curb Ramp With Two New Directional Ramps or Equivalent.**

Total Cost: \$ 3200.00
