# Access Compliance Report

## Public Rights-of-Way

### (Curb Ramps)

Intersection ID: 16757	Main Street: E_W_T_HARRIS_BV	Cross Street: MEADOWDALE_LN	Location: SW
ADA ID: 88F51F2AEA0A	Ramp Type: PerpDiag	Initial Pass/Fail: Fail	Overall Compliance: No
Severity Score: 25			
Codes/Mitigation Info/Possible Solution		Field Measurements/Component Compliance

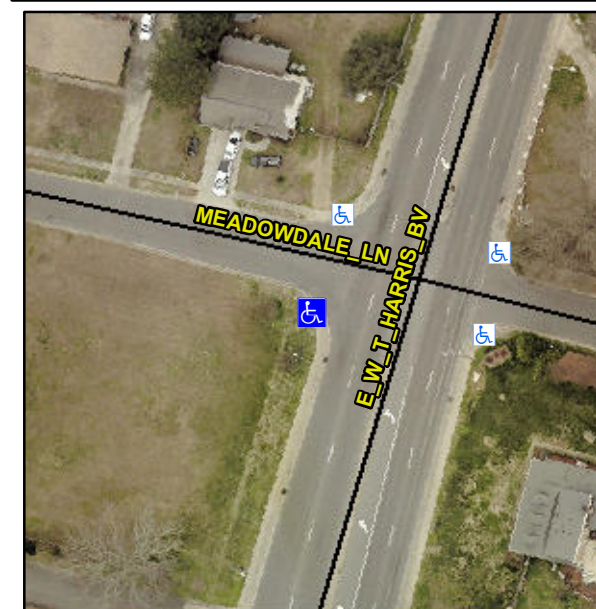
**R304.2.2, R304.5.3**

Compliance	Description	Data	Compliance	Description	Data
N/A	Ramp Length (in)	62.0	No	Ramp Slope (%)	11.1
Yes	Ramp Width (in)	48.0	No	Ramp XSlope (%)	6.3
N/A	Flare Type LT	N/A	N/A	Flare Type RT	N/A
N/A	Flare Slope LT (%)	N/A	N/A	Flare Slope RT (%)	N/A
N/A	Flare Traversable LT?	N/A	N/A	Flare Traversable RT?	N/A
N/A	Landing Length (in)	N/A	N/A	DWS Provided?	N/A
N/A	Landing Width (in)	N/A	N/A	DWS Contrast?	N/A
N/A	Landing Slope (%)	N/A	N/A	DWS Length (in)	N/A
N/A	Landing X Slope (%)	N/A	N/A	DWS Full Width?	N/A
N/A	Landing Curb? (Y/N)	N/A	N/A	DWS Offset (in)	N/A
N/A	Shared Landing?	N/A			
N/A	Gutter Ponding?	N/A	N/A	Gutter Slope (%)	N/A
N/A	Gutter Lip Ht (in)	N/A	N/A	Gutter X Slope (%)	N/A
N/A	Painted X Walk1?	No	N/A	Painted X Walk2?	No
	X Walk 1 Direction	To SE		X Walk 2 Direction	To NE
N/A	X Walk 1 Width (in)	N/A	N/A	X Walk 2 Width (in)	N/A
	X Walk 1 Slope (%)	6.1		X Walk 2 Slope (%)	2.1
	X Walk 1 X Slope (%)	0.2		X Walk 2 X Slope (%)	5.0

N/A	Ramp inside XWalk1?	N/A	N/A	Ramp inside XWalk2?	N/A
	Road Slope (%)	4.3	N/A	Clear Space?	N/A
	Road X Slope (%)	5.5	N/A	Clear Space to XWalk (in)	N/A
N/A	Any Obstructions?	N/A	N/A	Storm Grate/Utility Hazard?	N/A
	Obstruction Type			Storm Grate/Utility Type	
		N/A			N/A
		Yes		Surface Condition? (G/P)	Good

**Remove & Replace Curb Ramp With Two New Directional Ramps or Equivalent.**

Total Cost: \$ 3200.00
