Access Compliance Report

Public Rights-of-Way (Curb Ramps)

Intersection ID: 2509	Main Street: LYNNEWOOD_GLEN_DR	Cross Street: WHITEGATE_LN	Location: SW
ADA ID: 88F98A9D9C5F	Ramp Type: PerpDiag	Initial Pass/Fail: Fail	Overall Compliance: No
Severity Score: 22.5			
Codes/Mitigation Info/Possible Solution		Field Measurements/Component Compliance

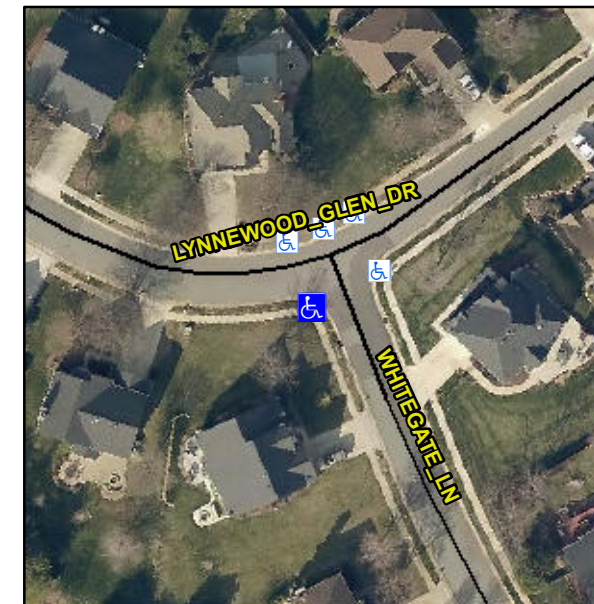
Not Found, R304.5.1, R304.2.2, R304.5.3

Compliance	Description	Data	Compliance	Description	Data
N/A	Ramp Length (in)	46.0	No	Ramp Slope (%)	10.4
No	Ramp Width (in)	42.0	No	Ramp XSlope (%)	4.4
N/A	Flare Type LT	N/A	N/A	Flare Type RT	N/A
N/A	Flare Slope LT (%)	N/A	N/A	Flare Slope RT (%)	N/A
N/A	Flare Traversable LT?	N/A	N/A	Flare Traversable RT?	N/A
N/A	Landing Length (in)	N/A	N/A	DWS Provided?	N/A
N/A	Landing Width (in)	N/A	N/A	DWS Contrast?	N/A
N/A	Landing Slope (%)	N/A	N/A	DWS Length (in)	N/A
N/A	Landing X Slope (%)	N/A	N/A	DWS Full Width?	N/A
N/A	Landing Curb? (Y/N)	N/A	N/A	DWS Offset (in)	N/A
N/A	Shared Landing?	N/A			
N/A	Gutter Ponding?	N/A	N/A	Gutter Slope (%)	N/A
N/A	Gutter Lip Ht (in)	N/A	N/A	Gutter X Slope (%)	N/A
N/A	Painted X Walk1?	No	N/A	Painted X Walk2?	No
	X Walk 1 Direction	To E		X Walk 2 Direction	To N
N/A	X Walk 1 Width (in)	N/A	N/A	X Walk 2 Width (in)	N/A
	X Walk 1 Slope (%)	1.2		X Walk 2 Slope (%)	1.3
	X Walk 1 X Slope (%)	3.2		X Walk 2 X Slope (%)	0.5

N/A	Ramp inside XWalk1?	N/A	N/A	Ramp inside XWalk2?	N/A
	Road Slope (%)	0.0	N/A	Clear Space?	N/A
	Road X Slope (%)	2.9	N/A	Clear Space to XWalk (in)	N/A
N/A	Any Obstructions?	N/A	N/A	Storm Grate/Utility Hazard?	N/A
	Obstruction Type			Storm Grate/Utility Type	
		N/A			N/A
			Yes	Surface Condition? (G/P)	Good

Possible Solutions:

Remove & Replace Curb Ramp With Two New Directional Ramps or Equivalent.
