Access Compliance Report

Public Rights-of-Way

(Curb Ramps)

Intersection ID: 6096	Main Street: BURMITH_AV	Cross Street: STATESVILLE_RD	Location: NW
ADA ID: 890236451D46	Ramp Type: Directional1	Initial Pass/Fail: Fail	Overall Compliance: No
Severity Score: 1.25			
Codes/Mitigation Info/Possible Solution		Field Measurements/Component Compliance

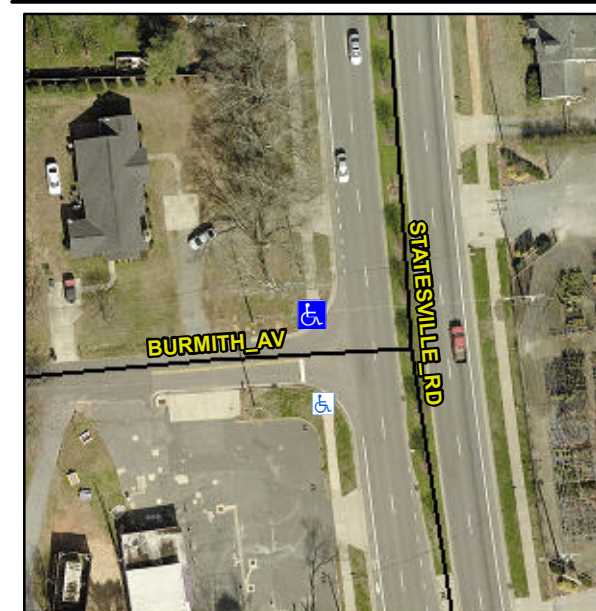
CRACK LT FL

R304.5.3

Compliance	Description	Data	Compliance	Description	Data
N/A	Ramp Length (in)	124.0	N/A	Grade Break?	N/A
Yes	Ramp Width (in)	71.5	N/A	Grade Break Slope (%)	0.0
Yes	Ramp Slope (%)	7.5	N/A	Grade Break XSlope (%)	0.0
No	Ramp XSlope (%)	2.5			
N/A	Flare Type LT	N/A	N/A	Flare Type RT	N/A
N/A	Flare Slope LT (%)	N/A	N/A	Flare Slope RT (%)	0.0
N/A	Flare Traversable LT?	N/A	N/A	Flare Traversable RT?	N/A
N/A	Landing Length (in)	0.0	N/A	DWS Provided?	N/A
N/A	Landing Width (in)	0.0	N/A	DWS Contrast?	N/A
N/A	Landing Slope (%)	0.0	N/A	DWS Length (in)	N/A
N/A	Landing X Slope (%)	0.0	N/A	DWS Full Width?	N/A
N/A	Landing Curb? (Y/N)	N/A	N/A	DWS Offset LT (in)	N/A
N/A	Shared Landing?	N/A	N/A	DWS Offset RT (in)	N/A
N/A	Gutter Ponding?	0.0	N/A	Gutter Slope (%)	N/A
N/A	Gutter Lip Ht (in)	0.0	N/A	Gutter X Slope (%)	N/A
N/A	Painted X Walk1?	No		Road Slope (%)	0.8
	X Walk 1 Direction	To S		Road X Slope (%)	0.2
	X Walk 1 Width (in)	N/A		Clear Space?	N/A

X Walk 1 Slope (%)	0.8	N/A	Clear Space to XWalk (in)	N/A
	X Walk 1 X Slope (%)	0.2	N/A	Storm Grate/Utility Hazard?	N/A
N/A	Ramp inside XWalk1?	N/A		Storm Grate/Utility Type	
N/A	Any Obstructions?	N/A			N/A
	Obstruction Type		Yes	Surface Condition? (G/P)	Good
			N/A	Curb Slope (%)	11.2

Remove & Replace Entire Ramp.
