Access Compliance Report

Public Rights-of-Way

(Curb Ramps)

Intersection ID: N/A	Main Street: N COLLEGE ST	Cross Street: E 8TH ST	Location: W
ADA ID: 8902B08A9591	Ramp Type: PerpDiag	Initial Pass/Fail: Fail	Overall Compliance: No
			Severity Score: 13.75

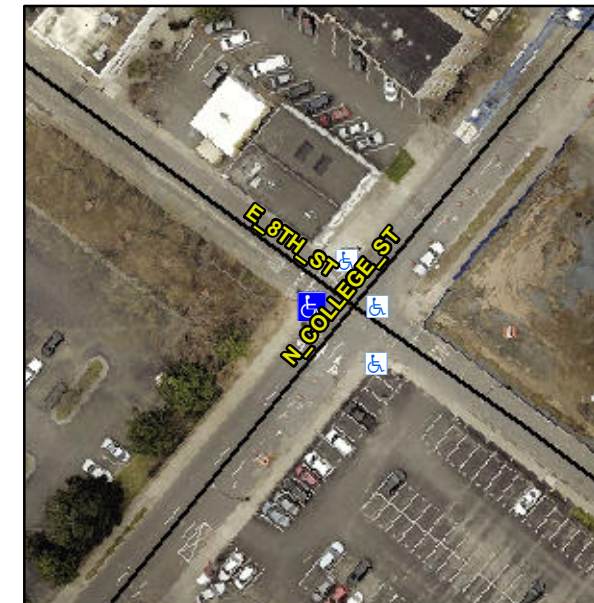
Not Found, R304.2.2, R304.5.3

Compliance	Description	Data	Compliance	Description	Data
N/A	Ramp Length (in)	72.0	No	Ramp Slope (%)	10.0
Yes	Ramp Width (in)	48.0	No	Ramp XSlope (%)	3.0
N/A	Flare Type LT	N/A	N/A	Flare Type RT	N/A
N/A	Flare Slope LT (%)	N/A	N/A	Flare Slope RT (%)	N/A
N/A	Flare Traversable LT?	No	N/A	Flare Traversable RT?	No
N/A	Landing Length (in)	N/A	N/A	DWS Provided?	N/A
N/A	Landing Width (in)	N/A	N/A	DWS Contrast?	N/A
N/A	Landing Slope (%)	N/A	N/A	DWS Length (in)	N/A
N/A	Landing X Slope (%)	N/A	N/A	DWS Full Width?	N/A
N/A	Landing Curb? (Y/N)	N/A	N/A	DWS Offset (in)	N/A
N/A	Shared Landing?	N/A			
N/A	Gutter Ponding?	N/A	N/A	Gutter Slope (%)	N/A
N/A	Gutter Lip Ht (in)	N/A	N/A	Gutter X Slope (%)	N/A
N/A	Painted X Walk1?	No	N/A	Painted X Walk2?	Yes
	X Walk 1 Direction	To SE		X Walk 2 Direction	To NE
N/A	X Walk 1 Width (in)	N/A	N/A	X Walk 2 Width (in)	101.0
	X Walk 1 Slope (%)	4.3		X Walk 2 Slope (%)	4.2
	X Walk 1 X Slope (%)	1.1		X Walk 2 X Slope (%)	1.3

N/A	Ramp inside XWalk1?	N/A	N/A	Ramp inside XWalk2?	Yes
	Road Slope (%)	1.2	N/A	Clear Space?	N/A
	Road X Slope (%)	3.8	N/A	Clear Space to XWalk (in)	N/A
N/A	Any Obstructions?	N/A	N/A	Storm Grate/Utility Hazard?	N/A
	Obstruction Type			Storm Grate/Utility Type	
		N/A			N/A
			Yes	Surface Condition? (G/P)	Good

Remove & Replace Curb Ramp With Two New Directional Ramps or Equivalent.

Total Cost: \$ 3200.00
