Access Compliance Report

Public Rights-of-Way

(Curb Ramps)

Intersection ID: 46394	Main Street: DRIWOOD_CT	Cross Street: CINNAMON_TEAL_DR	Location: W
ADA ID: 890B41CC876F	Ramp Type: Para	Initial Pass/Fail: Pass	Overall Compliance: No
		Severity Score: 0

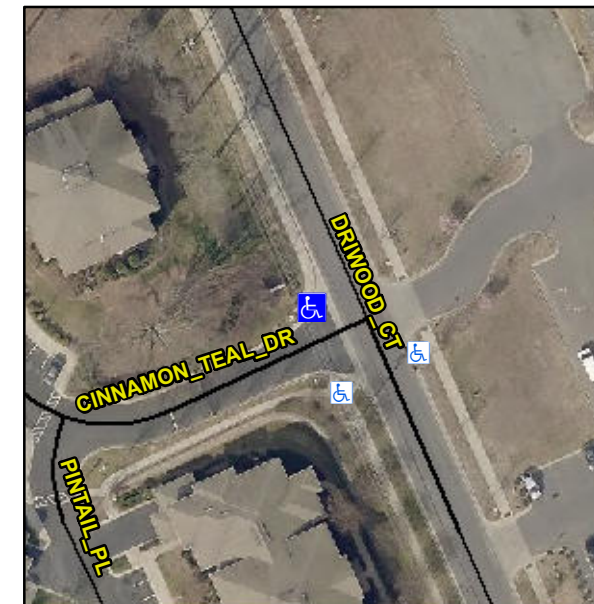
LT RP < 5%

Not Found, R304.2.1, R304.5.3

Compliance	Description	Data	Compliance	Description	Data
N/A	Ramp Length LT (in)	64.0	N/A	Ramp Length RT (in)	55.0
Yes	Ramp Width LT (in)	60.0	Yes	Ramp Width RT (in)	61.0
Yes	Ramp Slope LT (%)	2.2	Yes	Ramp Slope RT (%)	6.1
Yes	Ramp XSlope LT (%)	0.0	Yes	Ramp XSlope RT (%)	1.4
Yes	Landing Length (in)	60.0	Yes	DWS Provided?	Yes
No	Landing Width (in)	45.0	Yes	DWS Contrast?	Yes
Yes	Landing Slope (%)	1.5	Yes	DWS Length (in)	24.0
No	Landing X Slope (%)	2.7	Yes	DWS Full Width?	Yes
N/A	Landing Curb? (Y/N)	No	Yes	DWS Offset (in)	2.0
N/A	Shared Landing?	No			
Yes	Gutter Ponding?	No	Yes	Gutter Slope (%)	0.3
Yes	Gutter Lip Ht (in)	0.0	No	Gutter X Slope (%)	4.3
N/A	Painted X Walk1?	No	N/A	Painted X Walk2?	N/A
	X Walk 1 Direction	To SE		X Walk 2 Direction	N/A
N/A	X Walk 1 Width (in)	N/A	N/A	X Walk 2 Width (in)	N/A
	X Walk 1 Slope (%)	3.4		X Walk 2 Slope (%)	N/A
	X Walk 1 X Slope (%)	2.2		X Walk 2 X Slope (%)	N/A
N/A	Ramp inside XWalk1?	N/A	N/A	Ramp inside XWalk2?	N/A

Road Slope (%)	N/A	N/A	Clear Space?	Yes
	Road X Slope (%)	N/A	N/A	Clear Space to XWalk (in)	N/A
Yes	Any Obstructions?	No	Yes	Storm Grate/Utility Hazard?	No
	Obstruction Type			Storm Grate/Utility Type	
		N/A			N/A
			Yes	Surface Condition? (G/P)	Good
			Replace	Curb Slope (%)	10.5

Remove & Replace Entire Ramp.
Remove & Replace Gutter.
