# Access Compliance Report

## Public Rights-of-Way

### (Curb Ramps)

Intersection ID: 46188	Main Street: SEVEN_OAKS_DR	Cross Street: YAUPON_RD	Location: SW
ADA ID: 890C343CD926	Ramp Type: PerpDiag	Initial Pass/Fail: Fail	Overall Compliance: No
Severity Score: 12.5			
Codes/Mitigation Info/Possible Solution		Field Measurements/Component Compliance

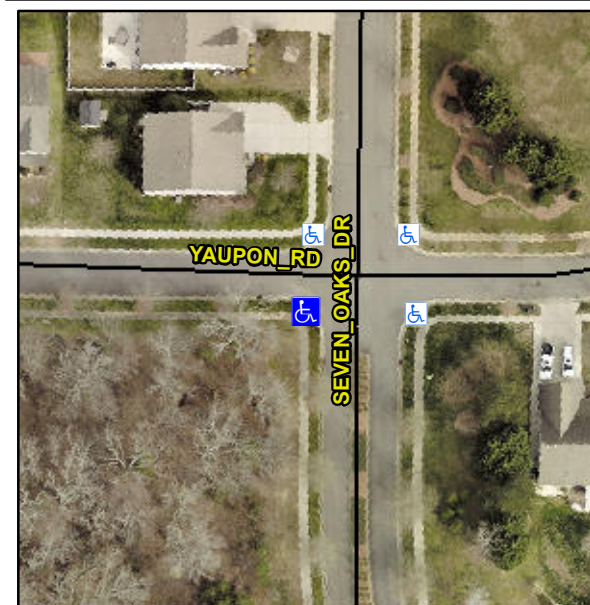
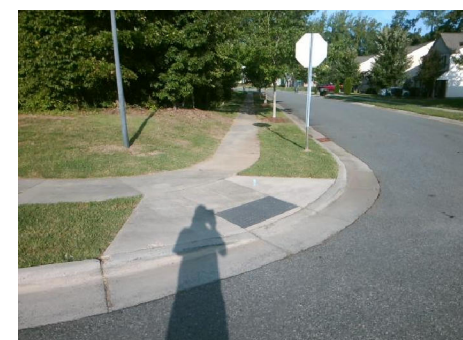
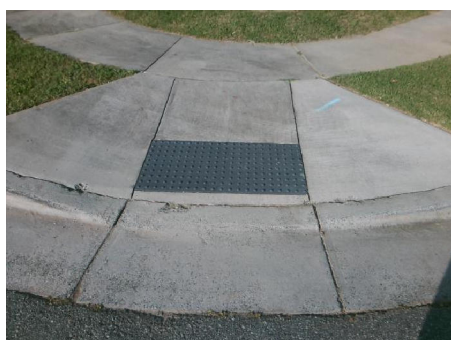
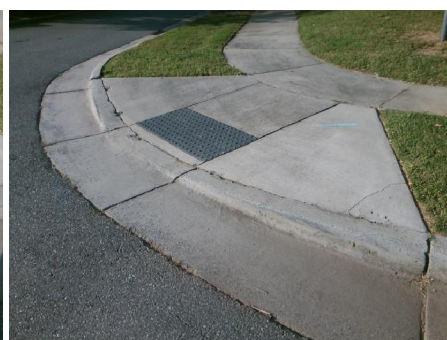
**Not Found, R304.2.2**

Compliance	Description	Data	Compliance	Description	Data
N/A	Ramp Length (in)	72.5	No	Ramp Slope (%)	9.1
Yes	Ramp Width (in)	48.0	Yes	Ramp XSlope (%)	0.7
N/A	Flare Type LT	N/A	N/A	Flare Type RT	N/A
N/A	Flare Slope LT (%)	N/A	N/A	Flare Slope RT (%)	N/A
N/A	Flare Traversable LT?	N/A	N/A	Flare Traversable RT?	N/A
N/A	Landing Length (in)	N/A	N/A	DWS Provided?	N/A
N/A	Landing Width (in)	N/A	N/A	DWS Contrast?	N/A
N/A	Landing Slope (%)	N/A	N/A	DWS Length (in)	N/A
N/A	Landing X Slope (%)	N/A	N/A	DWS Full Width?	N/A
N/A	Landing Curb? (Y/N)	N/A	N/A	DWS Offset (in)	N/A
N/A	Shared Landing?	N/A			
N/A	Gutter Ponding?	N/A	N/A	Gutter Slope (%)	N/A
N/A	Gutter Lip Ht (in)	1.0	N/A	Gutter X Slope (%)	N/A
N/A	Painted X Walk1?	No	N/A	Painted X Walk2?	No
	X Walk 1 Direction	To SE		X Walk 2 Direction	To N
N/A	X Walk 1 Width (in)	N/A	N/A	X Walk 2 Width (in)	N/A
	X Walk 1 Slope (%)	3.0		X Walk 2 Slope (%)	0.2
	X Walk 1 X Slope (%)	1.8		X Walk 2 X Slope (%)	1.4

N/A	Ramp inside XWalk1?	N/A	N/A	Ramp inside XWalk2?	N/A
	Road Slope (%)	2.9	N/A	Clear Space?	N/A
	Road X Slope (%)	0.4	N/A	Clear Space to XWalk (in)	N/A
N/A	Any Obstructions?	N/A	N/A	Storm Grate/Utility Hazard?	N/A
	Obstruction Type			Storm Grate/Utility Type	
		N/A			N/A
			Yes	Surface Condition? (G/P)	Good

**Remove & Replace Curb Ramp With Two New Directional Ramps or Equivalent.**
