Access Compliance Report

Public Rights-of-Way

(Curb Ramps)

Intersection ID: 27536	Main Street: DOWINGTON_DR	Cross Street: WOODRIVER_LN	Location: SW
ADA ID: 890CAECCF0BE	Ramp Type: Perp	Initial Pass/Fail: Fail	Overall Compliance: No
			Severity Score: 50

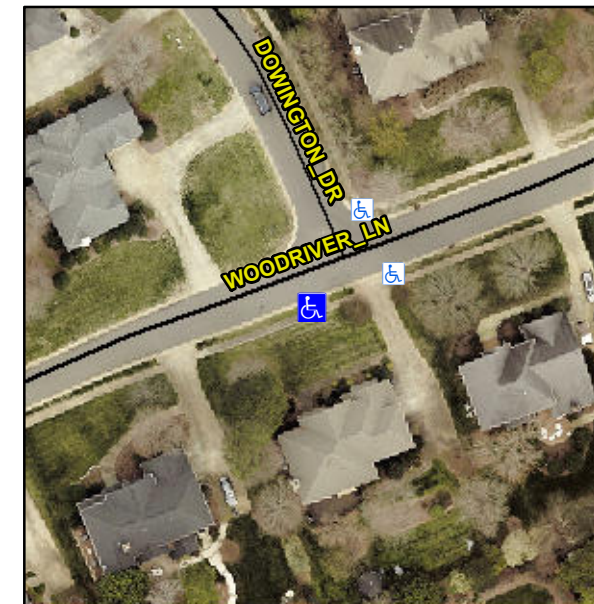
Compliance	Description	Data	Compliance	Description	Data
N/A	Ramp Length (in)	96.0	No	Ramp Slope (%)	12.4
Yes	Ramp Width (in)	48.0	No	Ramp XSlope (%)	8.1
N/A	Flare Type LT	N/A	N/A	Flare Type RT	N/A
N/A	Flare Slope LT (%)	N/A	N/A	Flare Slope RT (%)	N/A
N/A	Flare Traversable LT?	N/A	N/A	Flare Traversable RT?	N/A
N/A	Landing Length (in)	N/A	N/A	DWS Provided?	N/A
N/A	Landing Width (in)	N/A	N/A	DWS Contrast?	N/A
N/A	Landing Slope (%)	N/A	N/A	DWS Length (in)	N/A
N/A	Landing X Slope (%)	N/A	N/A	DWS Full Width?	N/A
N/A	Landing Curb? (Y/N)	N/A	N/A	DWS Offset (in)	N/A
N/A	Shared Landing?	N/A			
N/A	Gutter Ponding?	N/A	N/A	Gutter Slope (%)	N/A
N/A	Gutter Lip Ht (in)	N/A	N/A	Gutter X Slope (%)	N/A
N/A	Painted X Walk1?	No	N/A	Painted X Walk2?	N/A
	X Walk 1 Direction	To N		X Walk 2 Direction	N/A
N/A	X Walk 1 Width (in)	N/A	N/A	X Walk 2 Width (in)	N/A
	X Walk 1 Slope (%)	3.7		X Walk 2 Slope (%)	N/A
	X Walk 1 X Slope (%)	7.7		X Walk 2 X Slope (%)	N/A

Remove & Replace Entire Ramp.
