## Access Compliance Report Public Rights-of-Way (Curb Ramps)

Intersection ID: 10033236 Main Street: OAK\_LAKE\_BV Cross Street: N/A Location: W

ADA ID: 891D889F9F0A Ramp Type: PerpDiag Initial Pass/Fail: Pass Overall Compliance: No Severity Score: 27.5

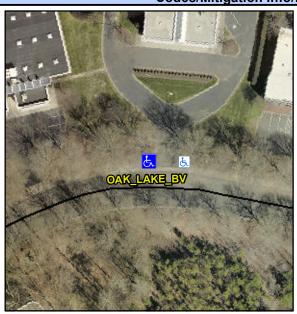
Street 1 Name OAK LAKE BV
Stop Condition-Street 2 None
Street 2 Name ENTRANCE
Stop Condition-Street 1 StopSign

Yes N/A Ramp Length (in) 47.0 Ramp Slope (%) Yes Ramp XSlope (%) Yes Ramp Width (in) 54.0 N/A Flare Type LT Sloped N/A Flare Type RT N/A Flare Slope LT (%) N/A Flare Slope RT (%) 2.8 N/A Flare Traversable LT? Yes N/A Flare Traversable RT? No Landing Length (in) N/A Yes DWS Provided? No Landing Width (in) N/A Yes **DWS Contrast?** No Landing Slope (%) N/A Yes DWS Length (in) No Landing X Slope (%) N/A No DWS Full Width? N/A Landing Curb? (Y/N) No No DWS Offset (in) N/A Shared Landing? No Gutter Ponding? Yes Yes Gutter Slope (%) No No Gutter Lip Ht (in) 1.0 Yes Gutter X Slope (%) N/A Painted X Walk1? No N/A Painted X Walk2? X Walk 1 Direction To S X Walk 2 Direction N/A N/A X Walk 1 Width (in) X Walk 2 Width (in) X Walk 1 Slope (%) 0.2 X Walk 2 Slope (%) X Walk 1 X Slope (%) 0.2 X Walk 2 X Slope (%) N/A N/A N/A Ramp inside XWalk2? Ramp inside XWalk1? Road Slope (%) 0.6 N/A Clear Space? N/A Road X Slope (%) 0.9 Clear Space to XWalk (in) No Yes Any Obstructions? Yes Storm Grate/Utility Hazard?

Remove & Replace Curb Ramp With Two New Directional Ramps or Equivalent. Grind Gutter Lip.

R304.2.1, R304.2.2-Perp, R304.3.2-Para, R304.5.3, R305.1.4, R305.2, R302.7, R302.7.2
