Access Compliance Report

Public Rights-of-Way (Curb Ramps)

Intersection ID: 48958	Main Street: TALUS_TRACE_LN	Cross Street: N/A	Location: W
ADA ID: 8928AB481302	Ramp Type: BlendTrans1	Initial Pass/Fail: Fail	Overall Compliance: No
			Severity Score: 21.25

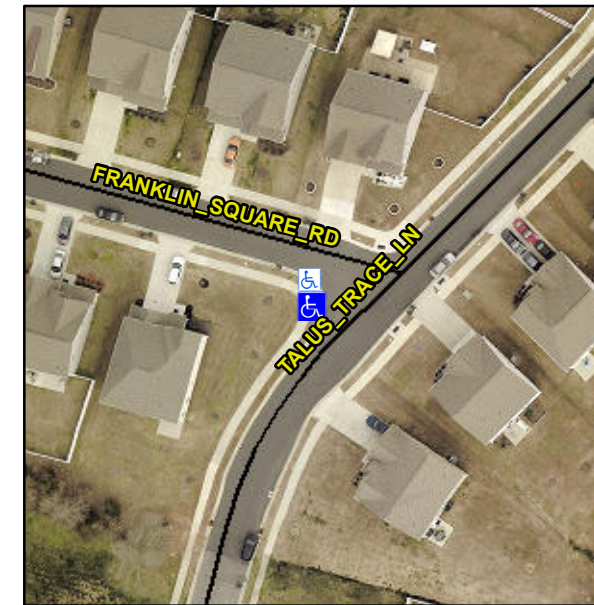
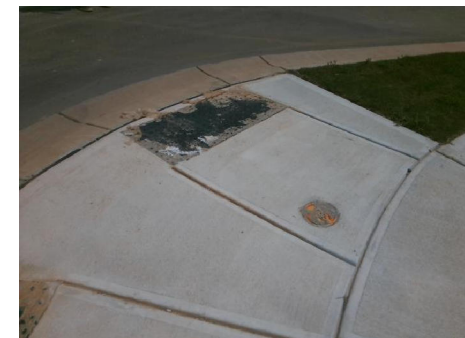
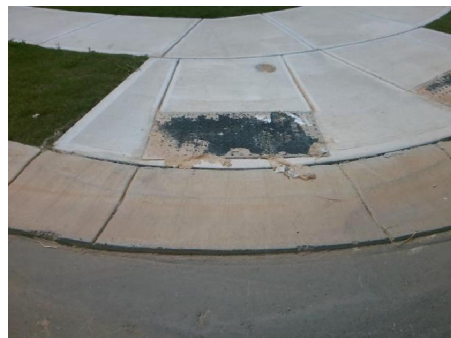
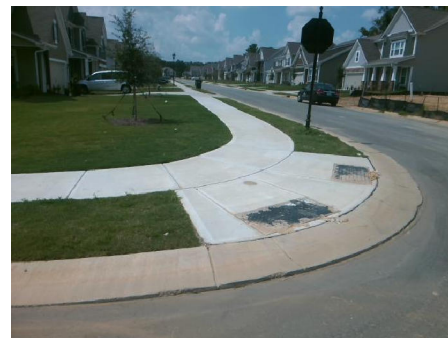
Compliance	Description	Data	Compliance	Description	Data
N/A	Ramp Length (in)	69.0	Yes	BlendTrans Slope (%)	4.7
No	Ramp Width (in)	41.0	No	BlendTrans XSlope (%)	5.2
N/A	Flare Type LT	N/A	N/A	Flare Type RT	N/A
N/A	Flare Slope LT (%)	N/A	N/A	Flare Slope RT (%)	N/A
N/A	Flare Traversable LT?	N/A	N/A	Flare Traversable RT?	N/A
N/A	Landing Length (in)	N/A	N/A	DWS Provided?	N/A
N/A	Landing Width (in)	N/A	N/A	DWS Contrast?	N/A
N/A	Landing Slope (%)	N/A	N/A	DWS Length (in)	N/A
N/A	Landing X Slope (%)	N/A	N/A	DWS Full Width?	N/A
N/A	Landing Curb? (Y/N)	N/A	N/A	DWS Offset (in)	N/A
N/A	Shared Landing?	N/A			
N/A	Gutter Ponding?	N/A	N/A	Gutter Slope (%)	N/A
N/A	Gutter Lip Ht (in)	1.0	N/A	Gutter X Slope (%)	N/A
N/A	Painted X Walk1?	No	N/A	Painted X Walk2?	N/A
	X Walk 1 Direction	To E		X Walk 2 Direction	N/A
	X Walk 1 Width (in)	N/A		X Walk 2 Width (in)	N/A
	X Walk 1 Slope (%)	3.3		X Walk 2 Slope (%)	N/A
	X Walk 1 X Slope (%)	4.7		X Walk 2 X Slope (%)	N/A

N/A	Ramp inside XWalk1?	N/A	N/A	Ramp inside XWalk2?	N/A
	Road Slope (%)	4.7		Clear Space?	N/A
	Road X Slope (%)	3.3	N/A	Clear Space to XWalk (in)	N/A
N/A	Any Obstructions?	N/A	N/A	Storm Grate/Utility Hazard?	N/A
	Obstruction Type			Storm Grate/Utility Type	
		N/A			N/A
			Yes	Surface Condition? (G/P)	Good
			No	Curb Slope (%)	23.4

Remove & Replace Curb Ramp With Two New Directional Ramps or Equivalent.

Not Found, R304.5.1, R304.5.3
