Access Compliance Report

Public Rights-of-Way

(Curb Ramps)

Intersection ID: 22223	Main Street: HUCKLEBERRY_RD	Cross Street: STOCKTIE_RD	Location: W
ADA ID: 8934C60EE5A4	Ramp Type: PerpDiag	Initial Pass/Fail: Fail	Overall Compliance: No
Severity Score: 58.75			
Codes/Mitigation Info/Possible Solution		Field Measurements/Component Compliance

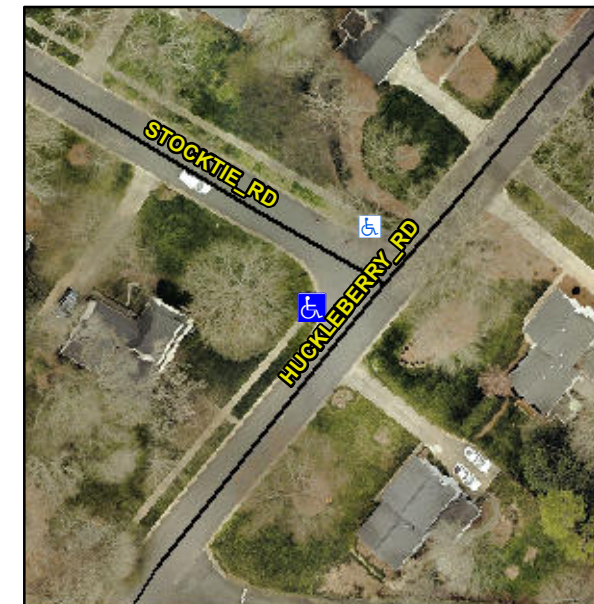
Not Found, R304.5.1, R304.2.2, R304.5.3

Compliance	Description	Data	Compliance	Description	Data
N/A	Ramp Length (in)	69.0	No	Ramp Slope (%)	12.1
No	Ramp Width (in)	39.0	No	Ramp XSlope (%)	8.9
N/A	Flare Type LT	N/A	N/A	Flare Type RT	N/A
N/A	Flare Slope LT (%)	N/A	N/A	Flare Slope RT (%)	N/A
N/A	Flare Traversable LT?	N/A	N/A	Flare Traversable RT?	N/A
N/A	Landing Length (in)	N/A	N/A	DWS Provided?	N/A
N/A	Landing Width (in)	N/A	N/A	DWS Contrast?	N/A
N/A	Landing Slope (%)	N/A	N/A	DWS Length (in)	N/A
N/A	Landing X Slope (%)	N/A	N/A	DWS Full Width?	N/A
N/A	Landing Curb? (Y/N)	N/A	N/A	DWS Offset (in)	N/A
N/A	Shared Landing?	N/A			
N/A	Gutter Ponding?	N/A	N/A	Gutter Slope (%)	N/A
N/A	Gutter Lip Ht (in)	N/A	N/A	Gutter X Slope (%)	N/A
N/A	Painted X Walk1?	No	N/A	Painted X Walk2?	No
	X Walk 1 Direction	To SE		X Walk 2 Direction	To NE
N/A	X Walk 1 Width (in)	N/A	N/A	X Walk 2 Width (in)	N/A
	X Walk 1 Slope (%)	2.6		X Walk 2 Slope (%)	3.7
	X Walk 1 X Slope (%)	2.9		X Walk 2 X Slope (%)	4.2

N/A	Ramp inside XWalk1?	N/A	N/A	Ramp inside XWalk2?	N/A
	Road Slope (%)	0.9	N/A	Clear Space?	N/A
	Road X Slope (%)	4.1	N/A	Clear Space to XWalk (in)	N/A
N/A	Any Obstructions?	N/A	N/A	Storm Grate/Utility Hazard?	N/A
	Obstruction Type			Storm Grate/Utility Type	
		N/A			N/A
			Yes	Surface Condition? (G/P)	Good

Possible Solutions:

Remove & Replace Curb Ramp With Two New Directional Ramps or Equivalent.
