# Access Compliance Report

## Public Rights-of-Way

### (Curb Ramps)

Intersection ID: 7368	Main Street: BURCH_DR	Cross Street: DISTRIBUTION_CENTER_DR	Location: SW
ADA ID: 8934E65FE3C0	Ramp Type: Perp	Initial Pass/Fail: Fail	Overall Compliance: No
Severity Score: 37.5			
Codes/Mitigation Info/Possible Solution		Field Measurements/Component Compliance

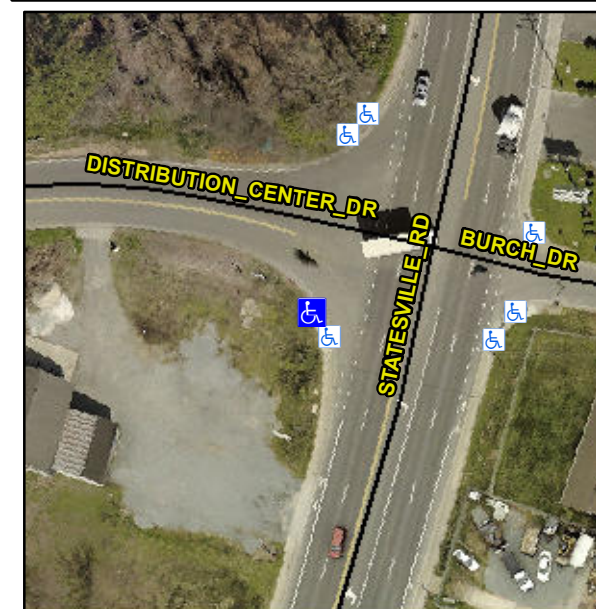
**Not Found, R304.5.1, R304.2.2, R304.5.3, R302.7**

Compliance	Description	Data	Compliance	Description	Data
N/A	Ramp Length (in)	61.0	No	Ramp Slope (%)	8.5
No	Ramp Width (in)	44.0	No	Ramp XSlope (%)	4.0
N/A	Flare Type LT	N/A	N/A	Flare Type RT	N/A
N/A	Flare Slope LT (%)	N/A	N/A	Flare Slope RT (%)	N/A
N/A	Flare Traversable LT?	N/A	N/A	Flare Traversable RT?	N/A
N/A	Landing Length (in)	N/A	N/A	DWS Provided?	N/A
N/A	Landing Width (in)	N/A	N/A	DWS Contrast?	N/A
N/A	Landing Slope (%)	N/A	N/A	DWS Length (in)	N/A
N/A	Landing X Slope (%)	N/A	N/A	DWS Full Width?	N/A
N/A	Landing Curb? (Y/N)	N/A	N/A	DWS Offset (in)	N/A
N/A	Shared Landing?	N/A			
N/A	Gutter Ponding?	N/A	N/A	Gutter Slope (%)	N/A
N/A	Gutter Lip Ht (in)	1.0	N/A	Gutter X Slope (%)	N/A
N/A	Painted X Walk1?	No	N/A	Painted X Walk2?	N/A
	X Walk 1 Direction	To NE		X Walk 2 Direction	N/A
N/A	X Walk 1 Width (in)	N/A	N/A	X Walk 2 Width (in)	N/A
	X Walk 1 Slope (%)	0.9		X Walk 2 Slope (%)	N/A
	X Walk 1 X Slope (%)	3.6		X Walk 2 X Slope (%)	N/A

N/A	Ramp inside XWalk1?	N/A	N/A	Ramp inside XWalk2?	N/A
	Road Slope (%)	N/A	N/A	Clear Space?	N/A
	Road X Slope (%)	N/A	N/A	Clear Space to XWalk (in)	N/A
N/A	Any Obstructions?	N/A	N/A	Storm Grate/Utility Hazard?	N/A
	Obstruction Type			Storm Grate/Utility Type	
		N/A			N/A
		No		Surface Condition? (G/P)	Poor

**Remove & Replace Entire Ramp.**

Total Cost: \$ 1850.00
