# Access Compliance Report

## Public Rights-of-Way

### (Curb Ramps)

| Intersection ID: 11597 | Main Street: E_20TH_ST | Cross Street: SEIGLE_AV | Location: SW |

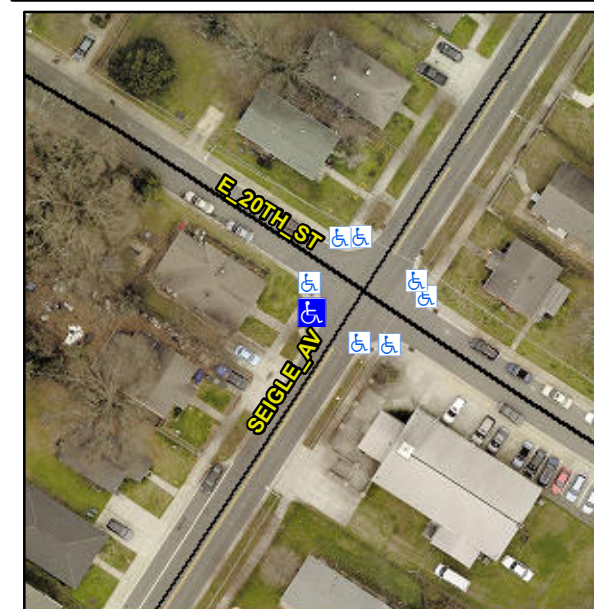
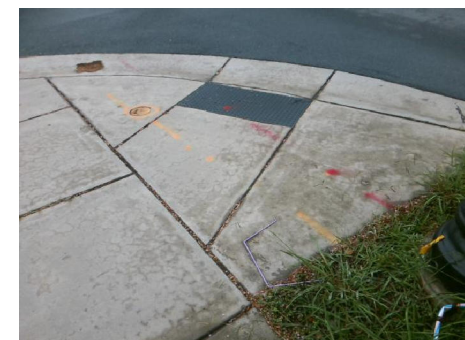
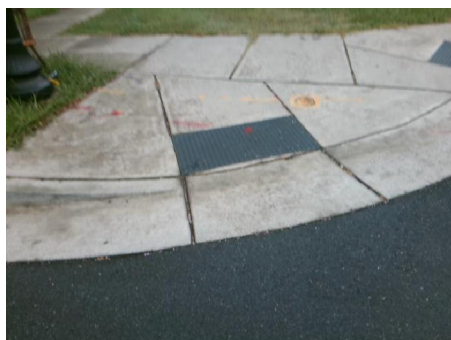
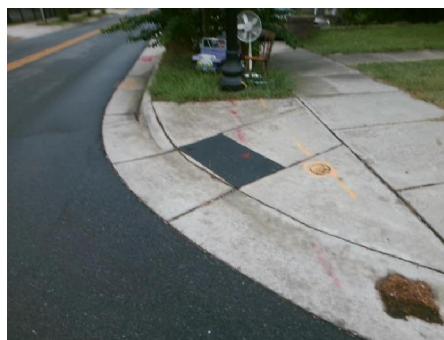
| ADA ID: 893A7A0DFC95 | Ramp Type: BlendTrans1 | Initial Pass/Fail: Fail | Overall Compliance: No |
| Severity Score: 12.5 | | | |

**Not Found, R304.5.3**

| Compliance | Description | Data | Compliance | Description | Data |
|---|---|---|---|---|---|
| Yes | Ramp Width (in) | 48.0 | No | BlendTrans XSlope (%) | 6.2 |
| | | | No | Curb Slope (%) | 7.9 |

**Remove & Replace Curb Ramp With Two New Directional Ramps or Equivalent.**

Total Cost: \$ 3200.00
