Access Compliance Report

Public Rights-of-Way

(Curb Ramps)

Intersection ID: 53888	Main Street: LOVELAND_DR	Cross Street: PAW_VALLEY_LN	Location: SW
ADA ID: 894ECFC41E9A	Ramp Type: PerpDiag	Initial Pass/Fail: Fail	Overall Compliance: No
Codes/Mitigation Info/Possible Solution		Field Measurements/Component Compliance	
Severity Score: 8.75

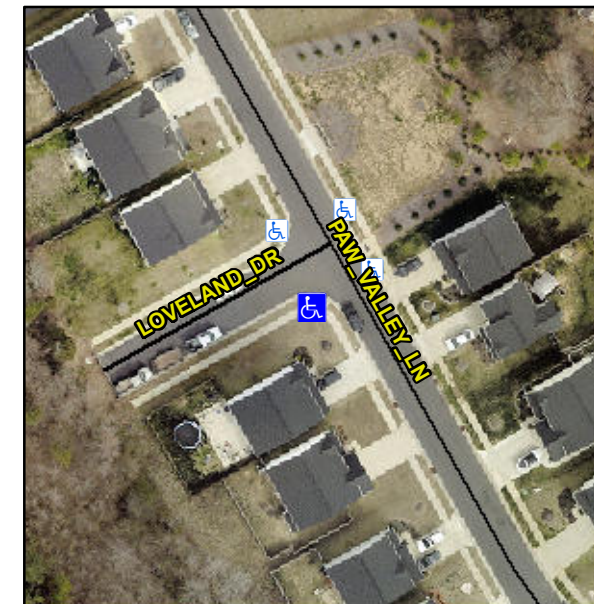
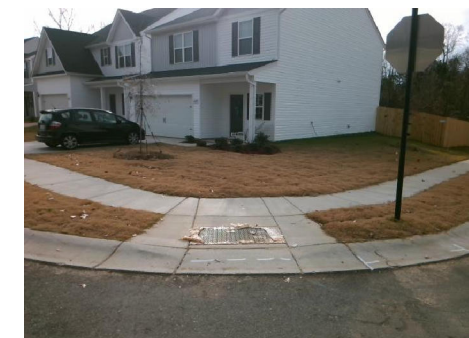
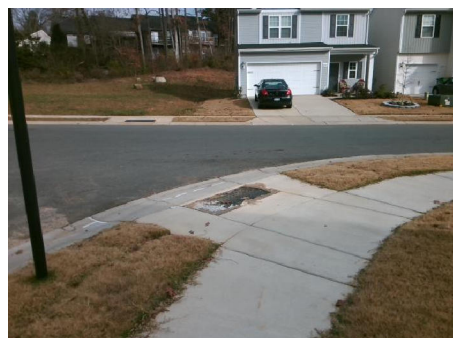
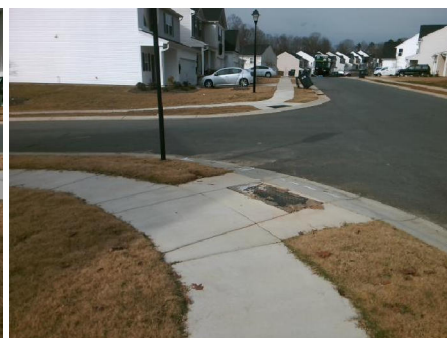
Not Found, R304.5.1

Compliance	Description	Data	Compliance	Description	Data
N/A	Ramp Length (in)	48.0	Yes	Ramp Slope (%)	5.0
No	Ramp Width (in)	47.0	Yes	Ramp XSlope (%)	1.0
N/A	Flare Type LT	N/A	N/A	Flare Type RT	N/A
N/A	Flare Slope LT (%)	N/A	N/A	Flare Slope RT (%)	N/A
N/A	Flare Traversable LT?	N/A	N/A	Flare Traversable RT?	N/A
N/A	Landing Length (in)	N/A	N/A	DWS Provided?	N/A
N/A	Landing Width (in)	N/A	N/A	DWS Contrast?	N/A
N/A	Landing Slope (%)	N/A	N/A	DWS Length (in)	N/A
N/A	Landing X Slope (%)	N/A	N/A	DWS Full Width?	N/A
N/A	Landing Curb? (Y/N)	N/A	N/A	DWS Offset (in)	N/A
N/A	Shared Landing?	N/A			
N/A	Gutter Ponding?	N/A	N/A	Gutter Slope (%)	N/A
N/A	Gutter Lip Ht (in)	N/A	N/A	Gutter X Slope (%)	N/A
N/A	Painted X Walk1?	No	N/A	Painted X Walk2?	No
	X Walk 1 Direction	To E		X Walk 2 Direction	To N
N/A	X Walk 1 Width (in)	N/A	N/A	X Walk 2 Width (in)	N/A
	X Walk 1 Slope (%)	4.4		X Walk 2 Slope (%)	3.1
	X Walk 1 X Slope (%)	5.0		X Walk 2 X Slope (%)	5.5

N/A	Ramp inside XWalk1?	N/A	N/A	Ramp inside XWalk2?	N/A
	Road Slope (%)	2.2	N/A	Clear Space?	N/A
	Road X Slope (%)	4.8	N/A	Clear Space to XWalk (in)	N/A
N/A	Any Obstructions?	N/A	N/A	Storm Grate/Utility Hazard?	N/A
	Obstruction Type			Storm Grate/Utility Type	
		N/A			N/A
		Yes		Surface Condition? (G/P)	Good

Remove & Replace Curb Ramp With Two New Directional Ramps or Equivalent.

Total Cost: \$ 3200.00
