Access Compliance Report Public Rights-of-Way (Curb Ramps)

Intersection ID: 14835 Main Street: DISTRIBUTION ST **Cross Street: REMOUNT RD** Location: N ADA ID: 895047D034E1 Ramp Type: PerpDiag Initial Pass/Fail: Fail **Overall Compliance: No** Severity Score: 13.75

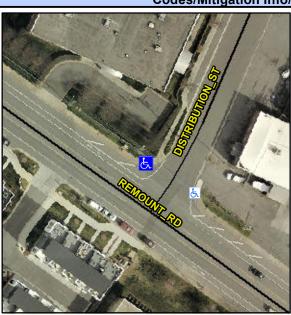
rtamp Longar (m)	00.0		rtamp Glope (70)	
Yes	Ramp Width (in)	48.0	No	Ramp XSlope (%)	
N/A	Flare Type LT	N/A	N/A	Flare Type RT	
N/A	Flare Slope LT (%)	N/A	N/A	Flare Slope RT (%)	
N/A	Flare Traversable LT?	N/A	N/A	Flare Traversable RT?	
N/A	Landing Length (in)	N/A	N/A	DWS Provided?	
N/A	Landing Width (in)	N/A	N/A	DWS Contrast?	
N/A	Landing Slope (%)	N/A	N/A	DWS Length (in)	
N/A	Landing X Slope (%)	N/A	N/A	DWS Full Width?	
N/A	Landing Curb? (Y/N)	N/A	N/A	DWS Offset (in)	
N/A	Shared Landing?	N/A			
N/A	Gutter Ponding?	N/A	N/A	Gutter Slope (%)	
N/A	Gutter Lip Ht (in)	N/A	N/A	Gutter X Slope (%)	
N/A	Painted X Walk1?	No	N/A	Painted X Walk2?	
	X Walk 1 Direction	To SW		X Walk 2 Direction	
N/A	X Walk 1 Width (in)	N/A	N/A	X Walk 2 Width (in)	
	X Walk 1 Slope (%)	2.9		X Walk 2 Slope (%)	
	X Walk 1 X Slope (%)	4.2		X Walk 2 X Slope (%)	
N/A	Ramp inside XWalk1?	N/A	N/A	Ramp inside XWalk2?	
	Road Slope (%)	3.3	N/A	Clear Space?

Road X Slope (%)	4.4	N/A	Clear Space to XWalk (in)	
N/A	Any Obstructions?	N/A	N/A	Storm Grate/Utility Hazard?	
	Obstruction Type			Storm Grate/Utility Type	
		NI/A

Remove & Replace Curb Ramp With Two New Directional Ramps or Equivalent.

Surveyor Notes:				
N/A				
PROW/ADA:				
Not Found, R304.2.2, R304.5.3				
Total Cost:	\$	3200.00
