| Intersection ID: 13389 | Main Street: ELIZABETH_AV | Cross Street: N_KINGS_DR | Location: | E |
| ADA ID: 8956900890E5 | Ramp Type: Perp | Initial Pass/Fail: Pass | Overall Compliance: No | Severity Score: 5 |

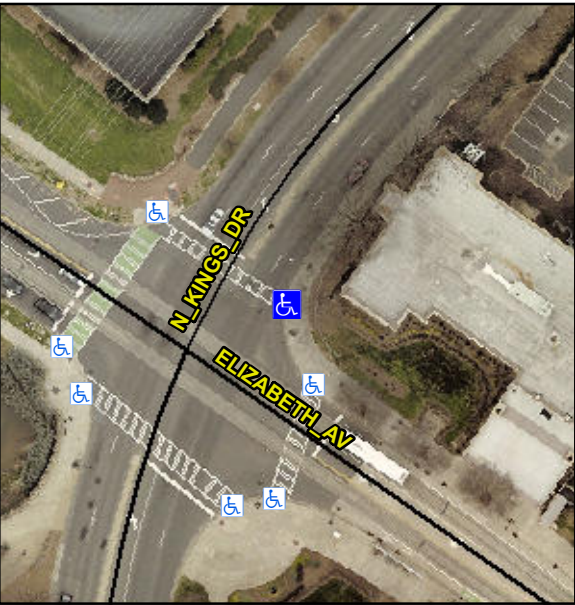
| Codes/Mitigation Info/Possible Solution | | | Field Measurements/Component Compliance | | | | | |
|---|---|---|---|---|---|---|---|---|
| | | | No | Landing Length (in) | 47.0 | Yes | DWS Provided? | Yes |
| | | | No | Landing Slope (%) | 3.1 | Yes | DWS Length (in) | 24.5 |
| | | | Yes | Gutter Ponding? | No | No | Gutter Slope (%) | 5.8 |
| <p>PROW/ADA:</p> <p>Not Found, R304.2.1, R304.2.2-Perp, R304.3.2-Para, R304.5.4</p> | | | | Road Slope (%) | N/A | N/A | Clear Space? | Yes |

| Codes/Mitigation Info/Possible Solution | | | Field Measurements/Component Compliance | | | | | |
|---|---|---|---|---|---|---|---|---|
| | Remove & Replace Entire Ramp.<br>Remove & Replace Gutter. | | N/A | Ramp Length (in) | 72.5 | Yes | Ramp Slope (%) | 7.7 |
