# Access Compliance Report

## Public Rights-of-Way (Curb Ramps)

Intersection ID: 26590	Main Street: PROVIDENCE_RD	Cross Street: COUNTRY_LN	Location: SE
ADA ID: 8964779FE3CF	Ramp Type: PerpDiag	Initial Pass/Fail: Fail	Overall Compliance: No
		Severity Score: 10

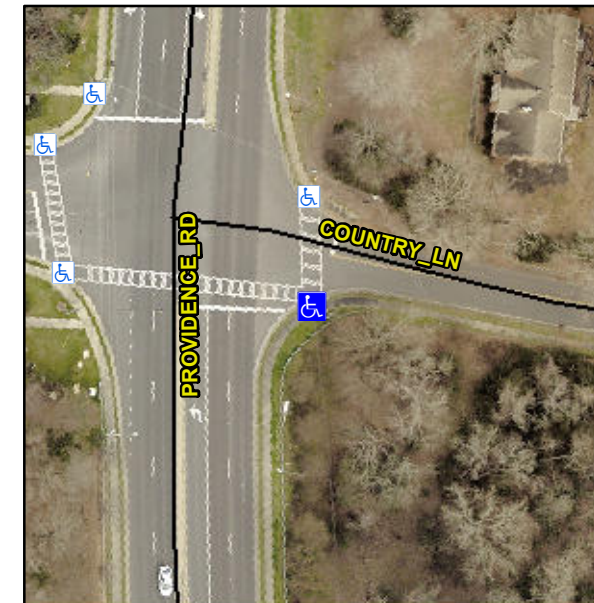
**Not Found, R304.5.1**

Compliance	Description	Data	Compliance	Description	Data
N/A	Ramp Length (in)	84.0	Yes	Ramp Slope (%)	5.2
No	Ramp Width (in)	46.5	Yes	Ramp XSlope (%)	4.1
N/A	Flare Type LT	N/A	N/A	Flare Type RT	N/A
N/A	Flare Slope LT (%)	N/A	N/A	Flare Slope RT (%)	N/A
N/A	Flare Traversable LT?	N/A	N/A	Flare Traversable RT?	N/A
N/A	Landing Length (in)	N/A	N/A	DWS Provided?	N/A
N/A	Landing Width (in)	N/A	N/A	DWS Contrast?	N/A
N/A	Landing Slope (%)	N/A	N/A	DWS Length (in)	N/A
N/A	Landing X Slope (%)	N/A	N/A	DWS Full Width?	N/A
N/A	Landing Curb? (Y/N)	N/A	N/A	DWS Offset (in)	N/A
N/A	Shared Landing?	N/A			
N/A	Gutter Ponding?	N/A	N/A	Gutter Slope (%)	N/A
N/A	Gutter Lip Ht (in)	N/A	N/A	Gutter X Slope (%)	N/A
N/A	Painted X Walk1?	Yes	N/A	Painted X Walk2?	Yes
	X Walk 1 Direction	To N		X Walk 2 Direction	To W
N/A	X Walk 1 Width (in)	111.0	N/A	X Walk 2 Width (in)	81.0
	X Walk 1 Slope (%)	6.8		X Walk 2 Slope (%)	6.1
	X Walk 1 X Slope (%)	5.9		X Walk 2 X Slope (%)	7.1

N/A	Ramp inside XWalk1?	Yes	N/A	Ramp inside XWalk2?	Yes
	Road Slope (%)	5.6	N/A	Clear Space?	N/A
	Road X Slope (%)	7.2	N/A	Clear Space to XWalk (in)	N/A
N/A	Any Obstructions?	N/A	N/A	Storm Grate/Utility Hazard?	N/A
	Obstruction Type			Storm Grate/Utility Type	
		N/A			N/A
		Yes		Surface Condition? (G/P)	Good

**Remove & Replace Curb Ramp With Two New Directional Ramps or Equivalent.**
